# Existing Facilities Assessment

## Dodge County Courthouse

Date: May 16, 2025

## Dodge County Courthouse Existing Facilities Assessment

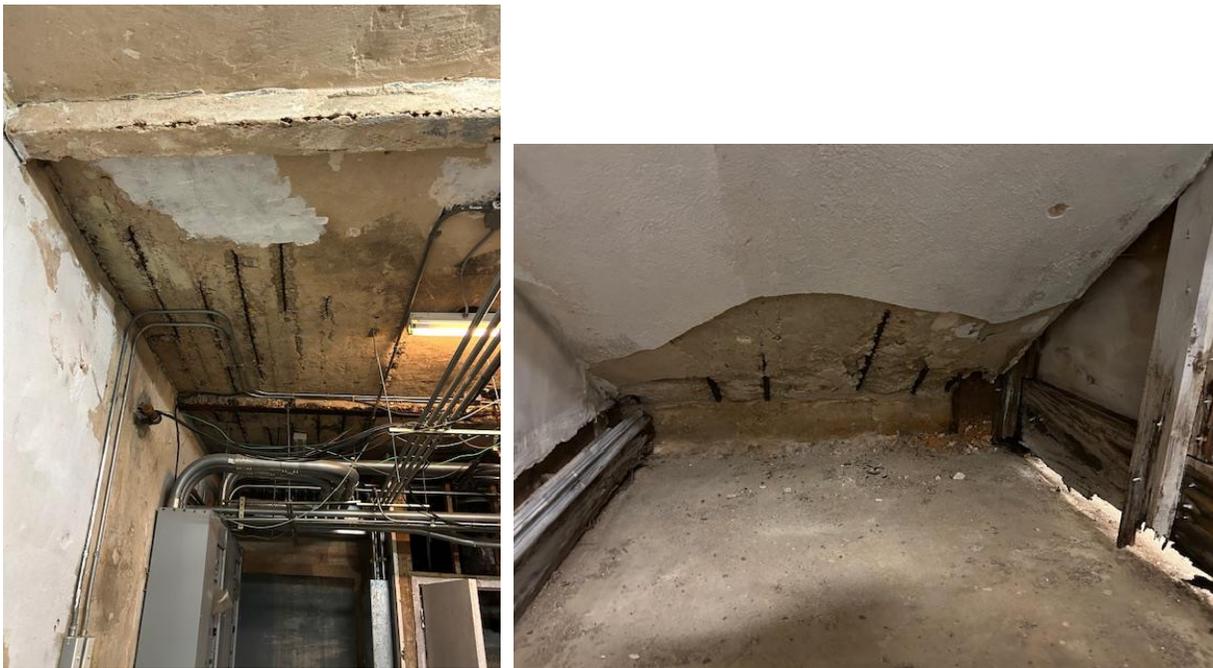
- Exposed reinforcement was observed on the underside of the concrete floor slab as well as under the concrete stair. The reinforcement was rusted and degraded. As the reinforcement rusts, it expands which causes the concrete around it to pop off and crack. The loss of section property of the rebar reduces the structural capacity of the floor. Only a small portion of the underside of the first elevated floor was reviewed during the site visit. There is concern that more instances of exposed reinforcement may exist within the crawlspace.

Exposed Reinforcement on the Underside of the First Floor

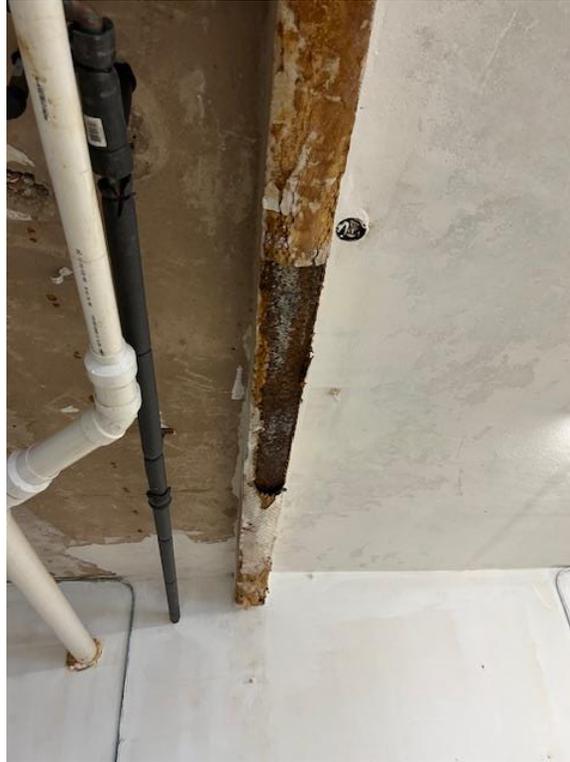
- The steel beams that support the concrete elevated slab appeared to be rusted particularly along the bottom flange. If more than 10% of the section property of the steel beam has degraded, the beam will require augmentation to maintain the structural integrity of the floor system. This condition was noted on both the basement and first floor levels.

Example of Rusted Beam Flange

- 4) Steel Remediation – Blast clean all steel elements and repair existing protective coatings. Steel should be cleaned of all rust, loose mill scale, loose paint and any other deposited material. After the steel has been cleaned, a testing lab should inspect the members to determine if more than 10% of the steel was lost through deterioration. Steel having more than 10% degradation of material needs to be replaced or repaired. If it is determined that some of the existing steel members need to be repaired, Shear Structural can work with the contractor to provide the necessary details specific for each condition and structural member.
- 5) Water Intrusion – Water intrusion into the basement/crawlspace must be stopped to prevent further corrosion of the steel and concrete members.

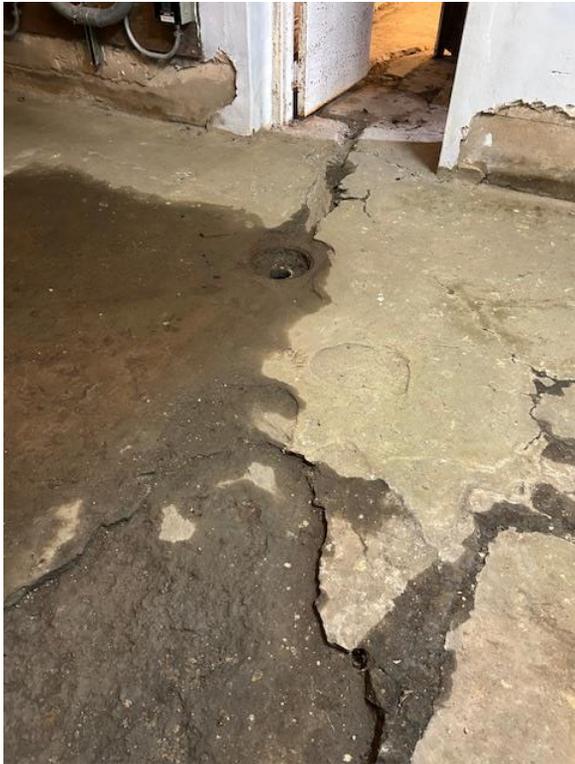
- On the north and west elevations of the building, there are entry points to the basement/crawlspace. The west entry point was flooded with water during the site visit. The north entry point showed evidence of past flooding. Water is infiltrating the basement at these locations. The slab on grade in the basement was trenched to aid the flow of water infiltrating the building to the floor drain.

Trenching of Basement Slab on Grade

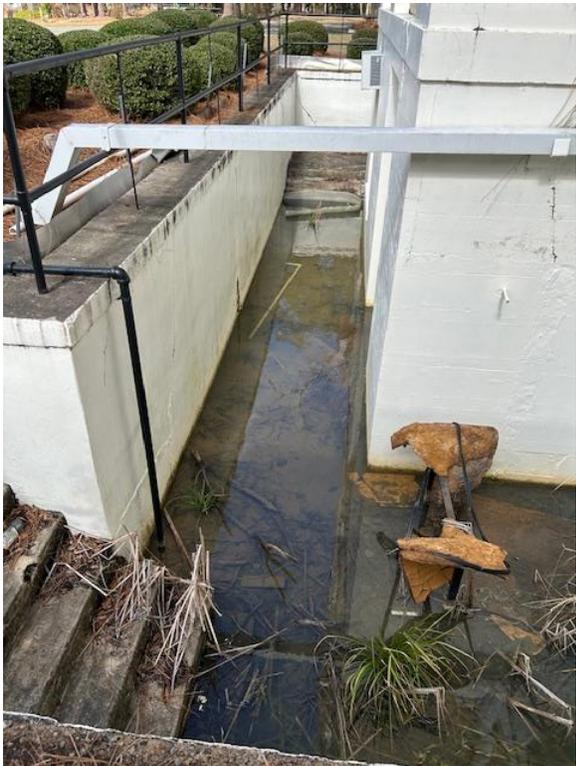
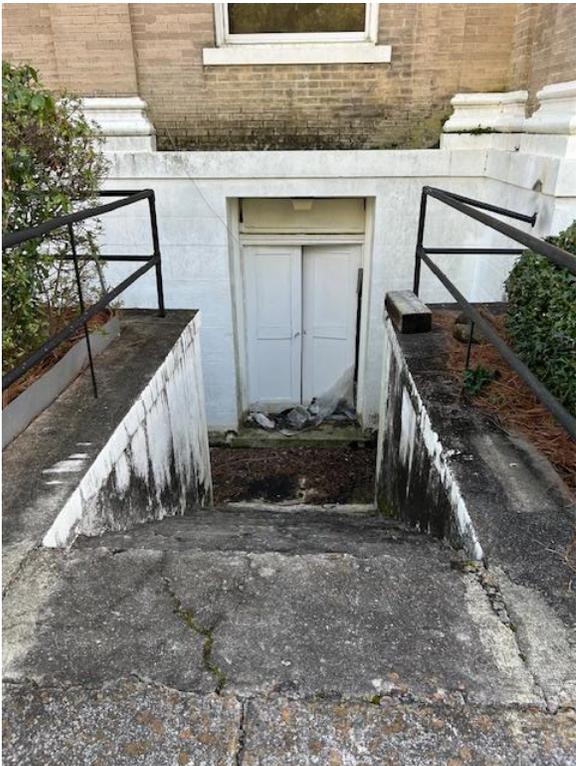
Water Infiltration at Basement Entries

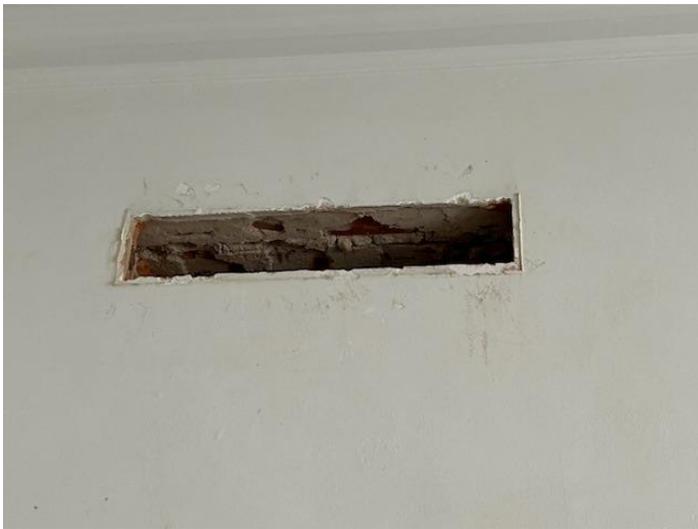
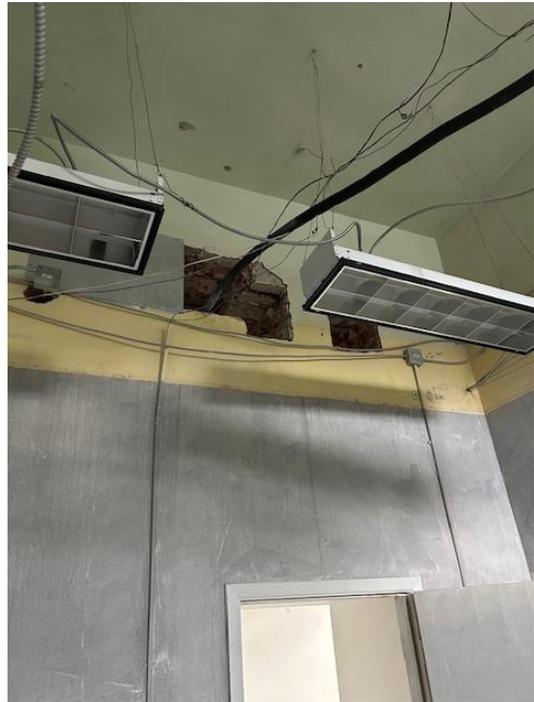
- Several wall penetrations within the multiwythe brick interior walls were found to be unsupported. No visible lintel was observed.

Example of Unsupported Masonry Above Openings

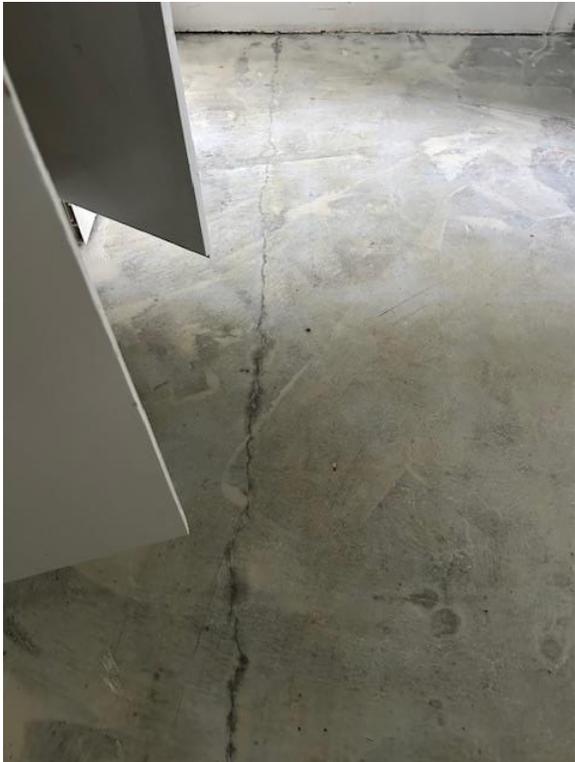
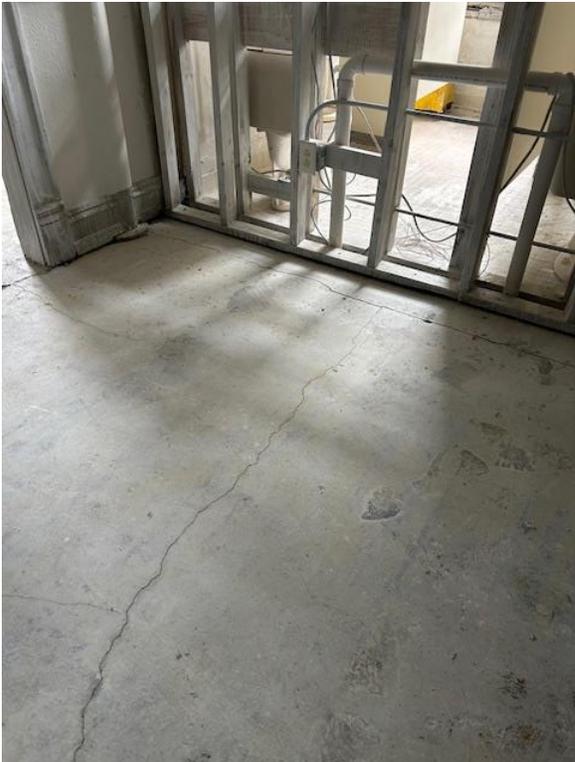
- Cracks in the elevated floor slab were prevalent throughout the building. In general, the cracks appear to be located over the load bearing elements below. Only a limited area of the floor below was accessible during the site visit, so the support for the first floor is generally unknown. However, based on the cracking noted on the second floor, it is assumed that the cracks are following a similar pattern. Some cracks were hairline cracks with others extending almost the full depth of the slab. The location of the cracks indicates a lack of tension reinforcing in the slab. The slab is believed to be cracking over the supports below as the support points are where negative moments occur in the slab. The cracks can be repaired but may continue to open up if no tension reinforcing is located in the slab.

Examples of Elevated Slab Cracking

- 1) Crack Remediation – We recommend open slab cracks greater than 0.05mm in width be repaired with pressure injected epoxy resin. Balance of open cracks should be routed and filled with an elastomeric joint sealant.
- 2) Where rusted reinforcement is found, any cracked, loose or spalled concrete should be removed to expose the affected reinforcing steel. Sandblast steel to remove corrosion. Splice new steel where more than 10% of the section reinforcing loss has occurred. Anchor new reinforcing in beams, size to match existing. Remaining concrete shall be cleaned and prepared to receive a bonding agent. Apply an anticorrosion agent to exposed reinforcement and patch concrete. Apply a sealer.
- 3) Surface delaminations and spalls – Damaged and loose concrete should be removed in its entirety down to sound concrete, all reinforcement cleaned with a corrosion inhibitor

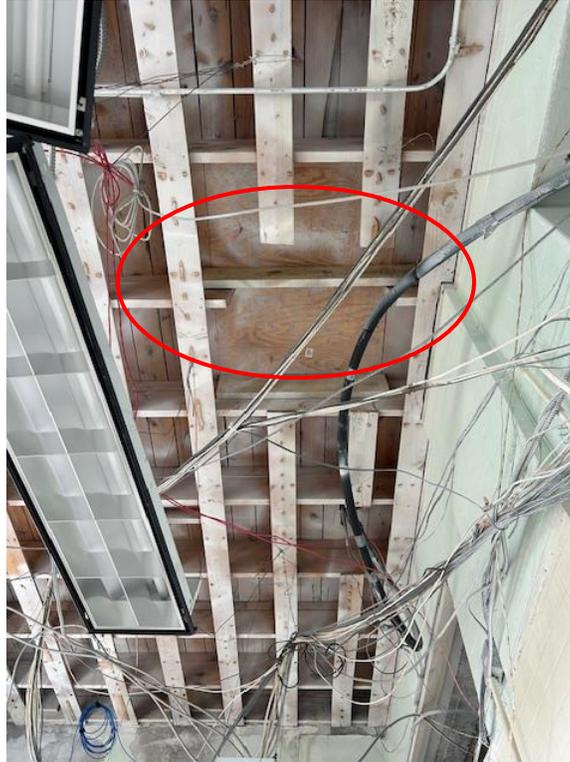
- On the west elevation, there is a single story bump out where the low roof is framed with wood 2x joists. One of the joists was observed to be cut and insufficiently spliced.

Incorrectly Spliced Wood Joist

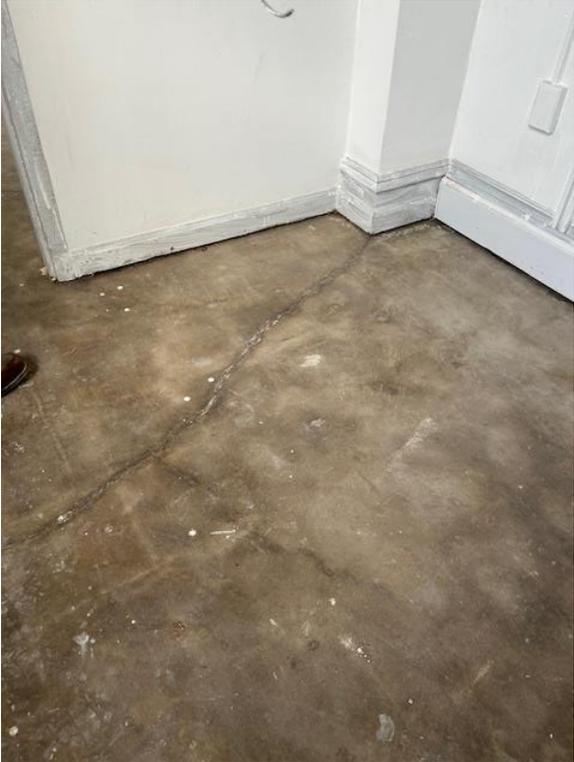
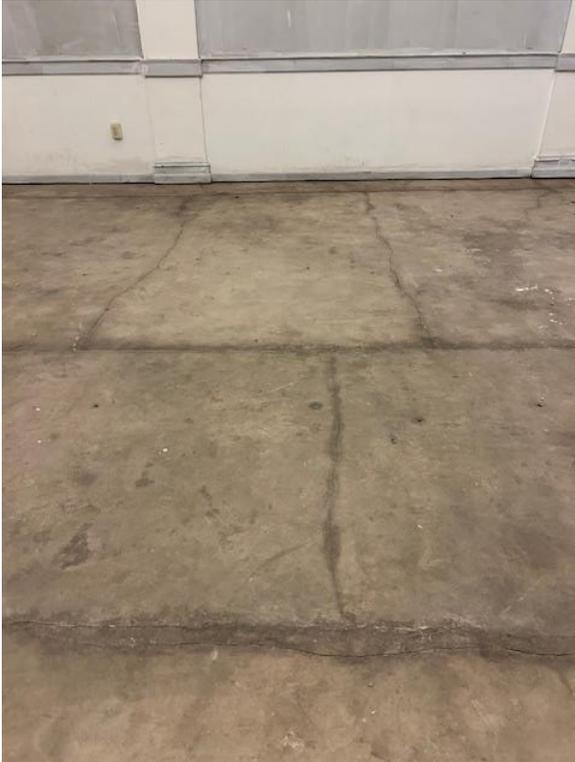
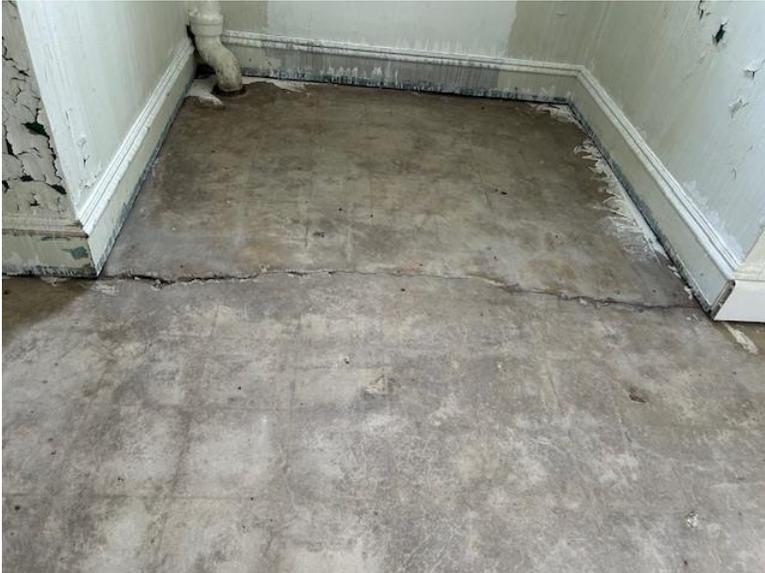
- Cracking in the elevated slab similar to the first floor were also found on the second floor. In general, the cracks appear to be located over the load bearing masonry walls below. Some cracks were hairline cracks with others extending almost the full depth of the slab. The location of the cracks indicates a lack of tension reinforcing in the slab. The slab is cracking over the walls below as the walls are the support point where negative moments occur in the slab. The cracks can be repaired but may continue to open up if no tension reinforcing is located in the slab.

Examples of Elevated Floor Cracking at the Second Floor

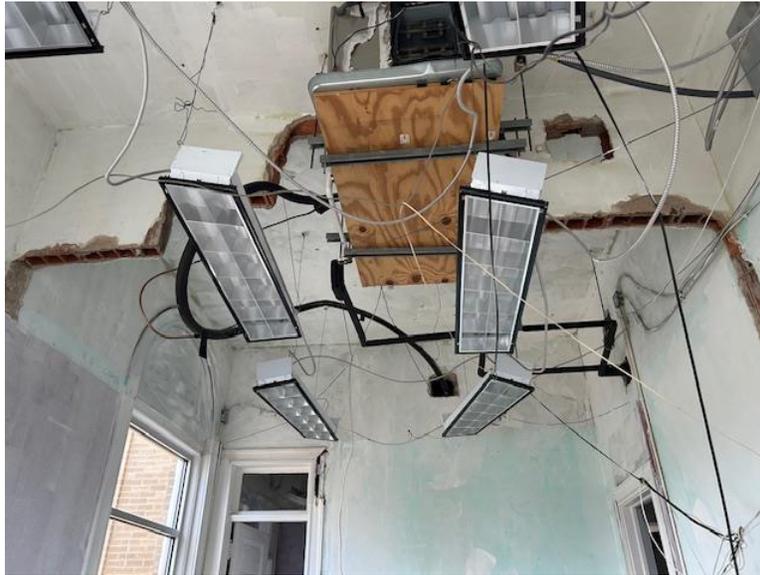
- A partially demolished interior masonry wall was noted in one room. The wall is currently unsupported. The wall should be shored immediately to prevent damage or injury should the wall fall.

Unsupported Interior Masonry Wall

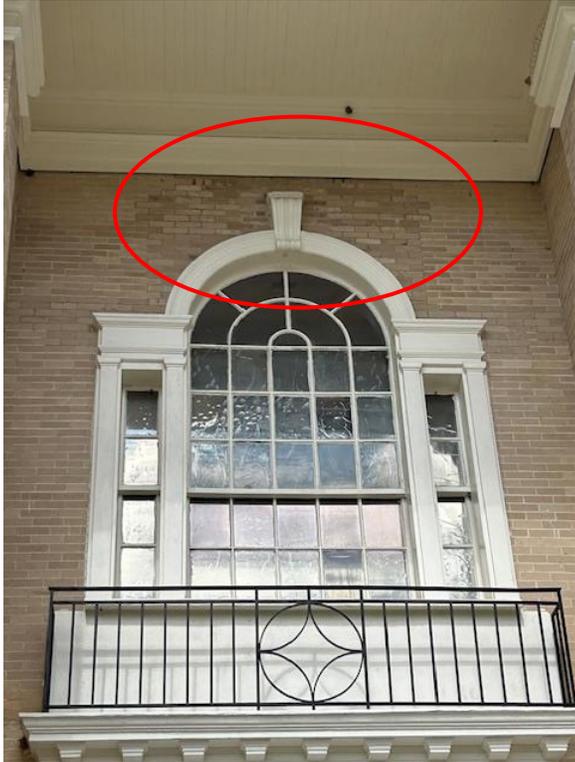
- On the North elevation, movement in the brick was noted above a second floor window.

Movement in Brick

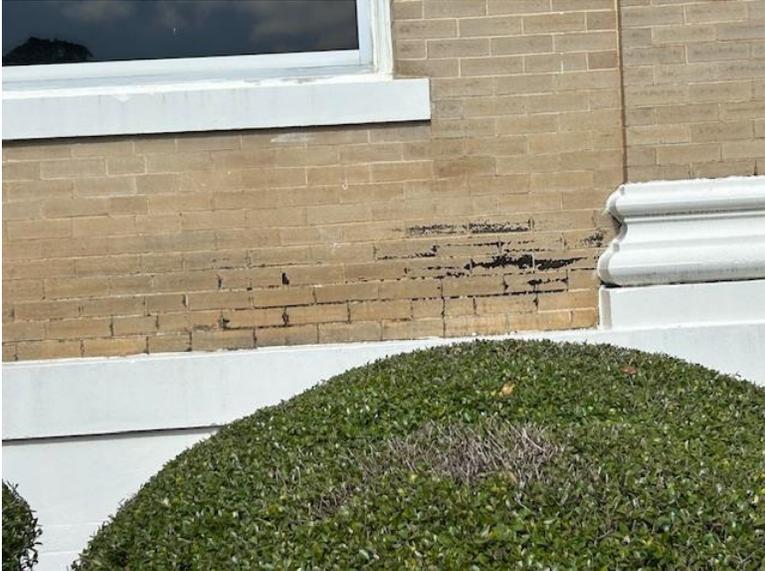
- Limited areas of brick were observed to have organic matter on the surface. This may be an indication of a water problem on the exterior envelope.

Discoloration of Brick

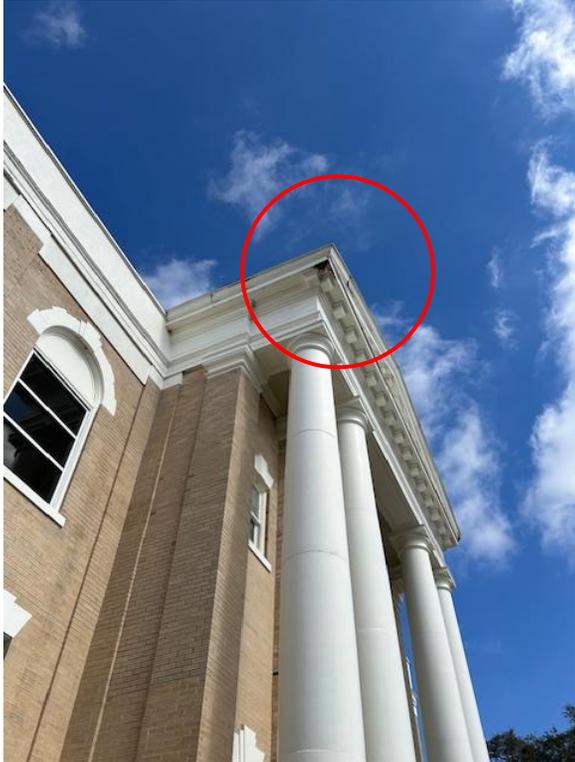
- Limited areas of damaged or rotten wood soffit were observed.

Example of Rotten/Damaged Wood Soffit

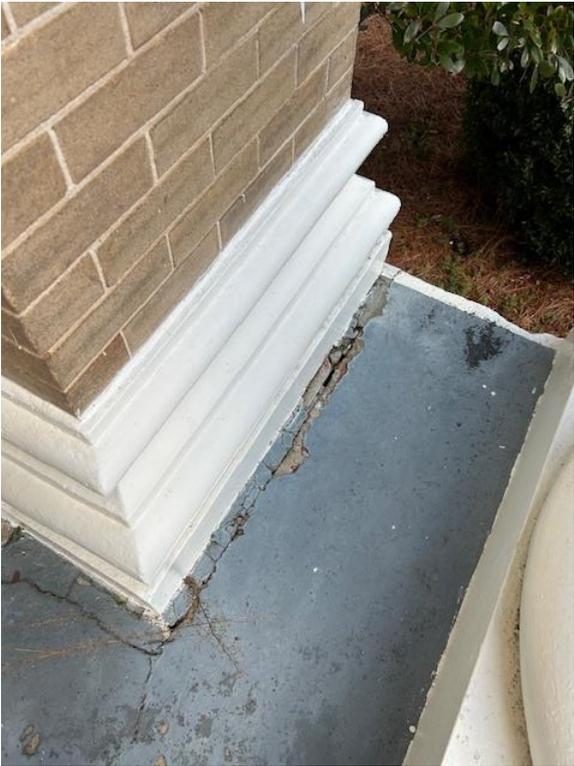
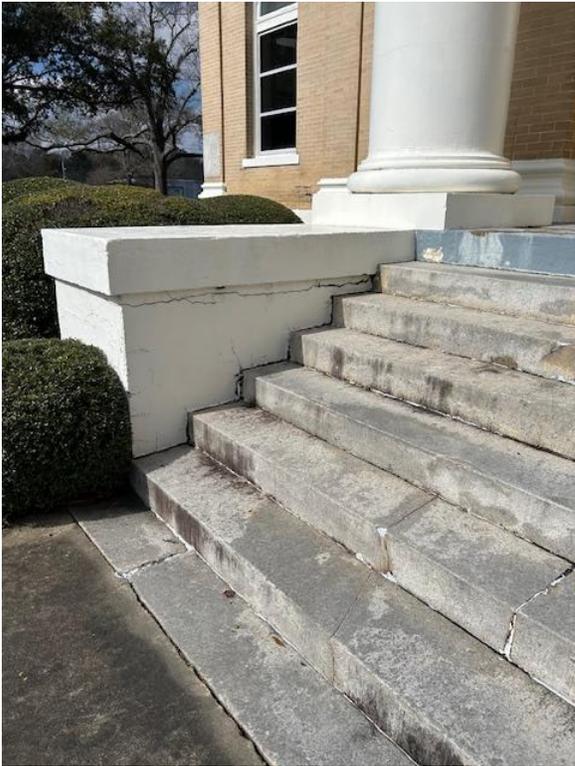
- Cracking around the main stair entry and columns were noted. This may be a result of settlement.

Cracking at Main Entry Stair and Landing

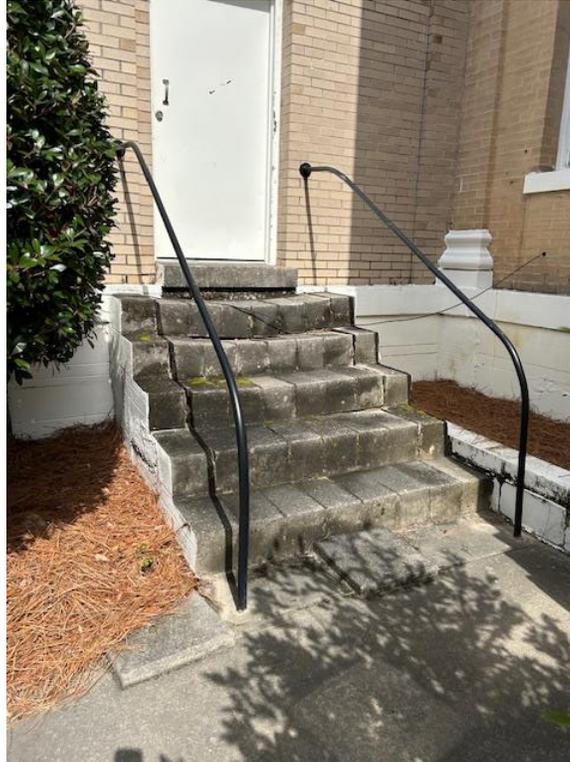
- Settlement has occurred at a masonry stair on the west elevation.

Sagging Masonry Stair

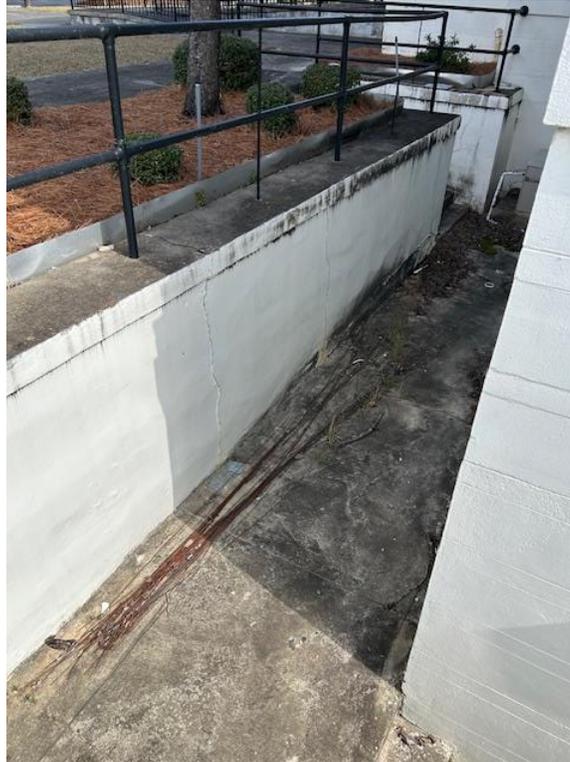
- Cracks were found in the concrete retaining walls at the basement entries.

Cracking in Concrete Retaining Walls

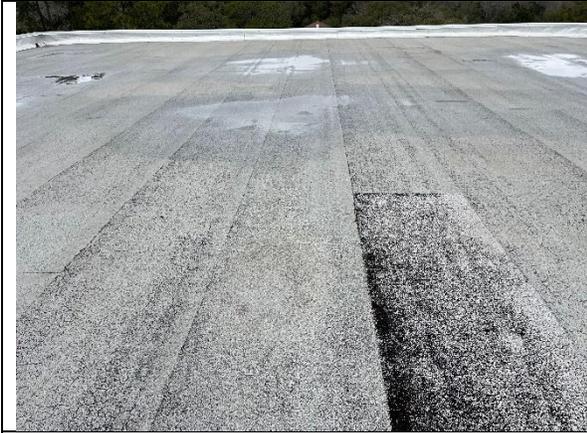
Photo 5: Overview of the main low-sloped roof, showing deteriorated cap sheet membrane and loss of granules

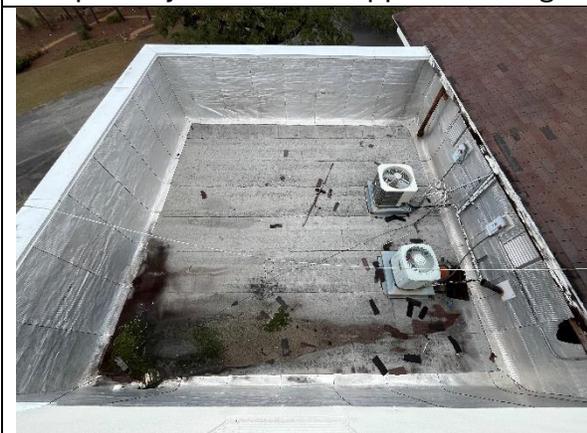
Photo 9: Overview of the north-west level 2 roof area, showing parapet wall, wall flashing system, water ponding/stains, and rooftop units

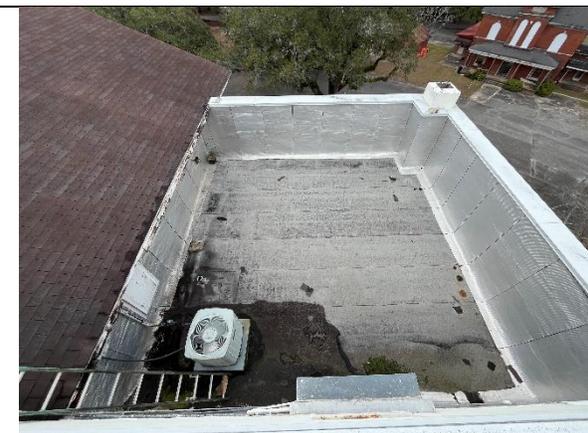
Photo 10: Overview of the north-east level 2 roof area, showing parapet wall, wall flashing system, water ponding/stains, and rooftop unit

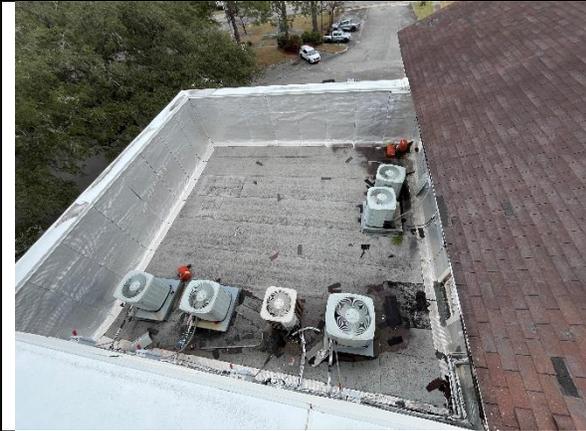
Photo 11: Overview of the south-east level 2 roof area, showing parapet wall, wall flashing system, water stains, and rooftop units

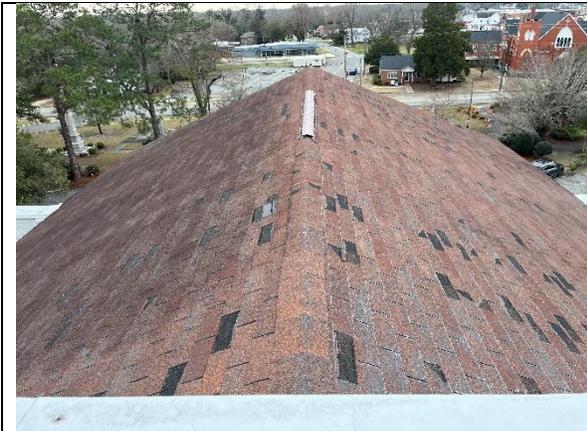
Photo 20: Overview of the south shingled roof, showing aged / missing / damaged shingles

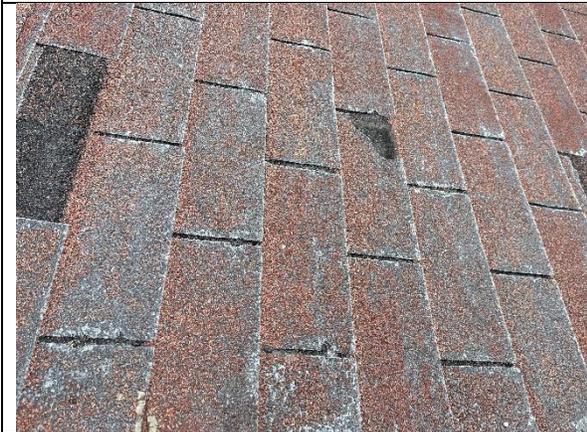
Photo 22: Close-up area, showing aged / missing / damaged shingles

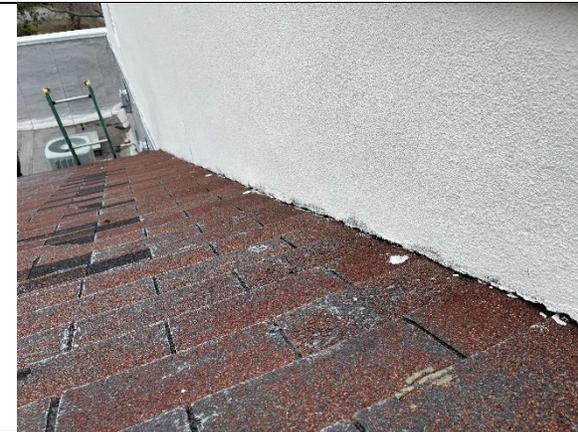
Photo 23: Missing flashing at a transition area of shingles to a plaster rising wall.

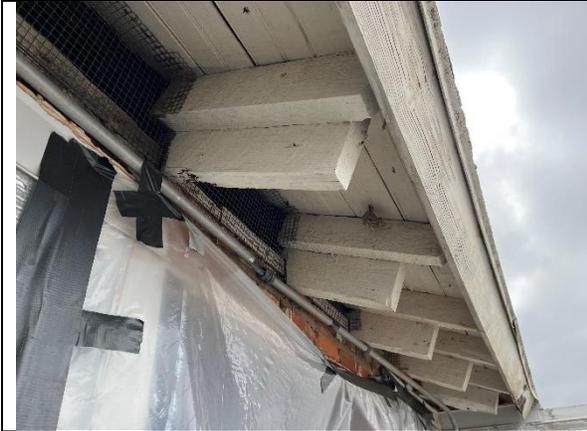
Photo 24: Edge of shingled roof framing at wood soffit, showing missing gutter

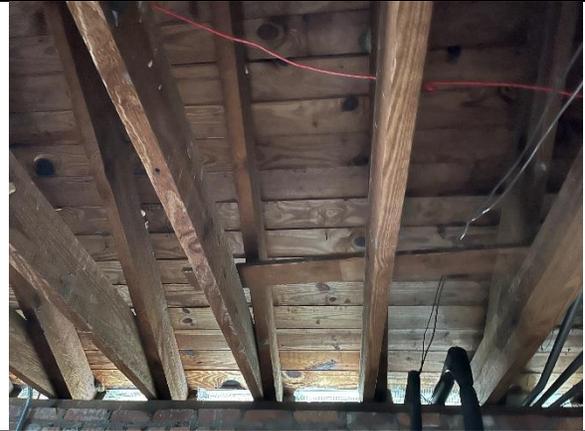
Photo 25: Edge of shingled roof framing at wood soffit viewed from the interior. Showing open / unsealed area

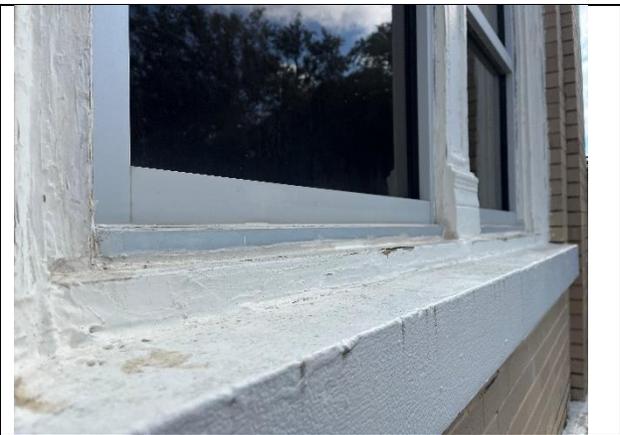
Photo 29: Detailed view of a typical retrofit aluminum assembly with existing wood trim. Note signs of moisture and sealant repairs.

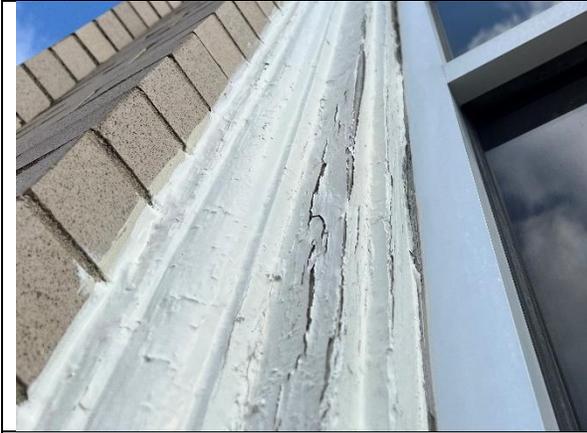
Photo 30: A typical retrofit aluminum assembly with existing wood trim. Note signs of major moisture damage and sealant repairs.

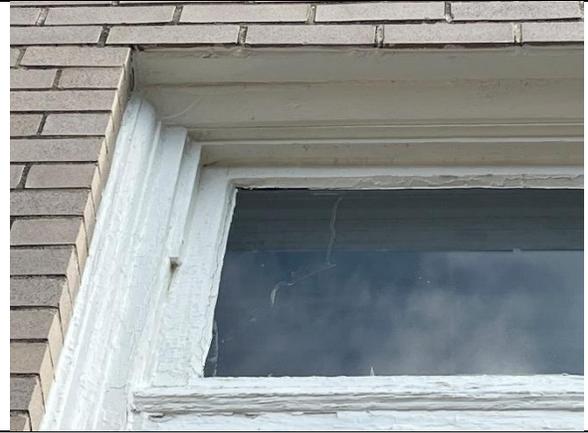
Photo 31: Existing wood window at the transom above a retrofit aluminum assembly. Note signs of moisture and sealant repairs.

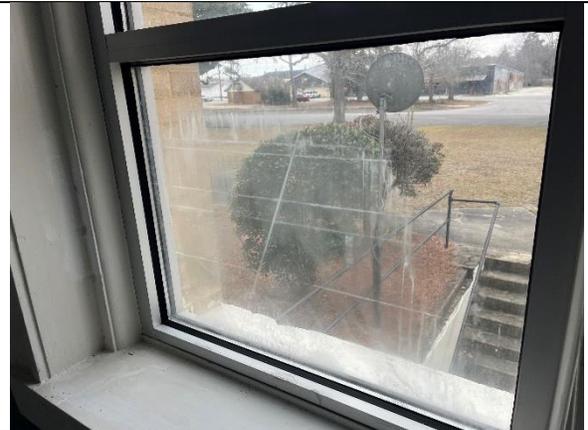
Photo 34: Aluminum-framed transom above a doorway with loose / displaced gaskets.

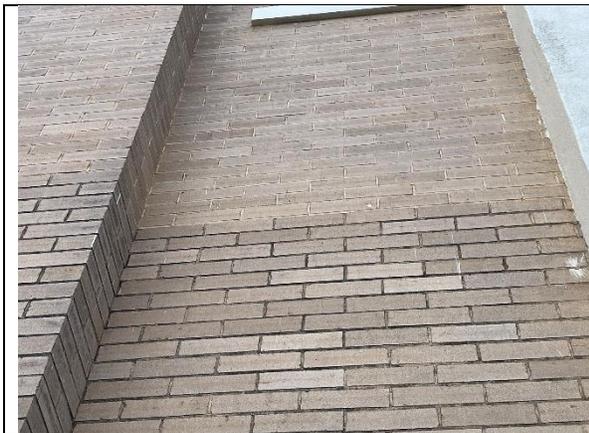
Photo 46: Variation in the mortar staining near the 2<sup>nd</sup> floor line.

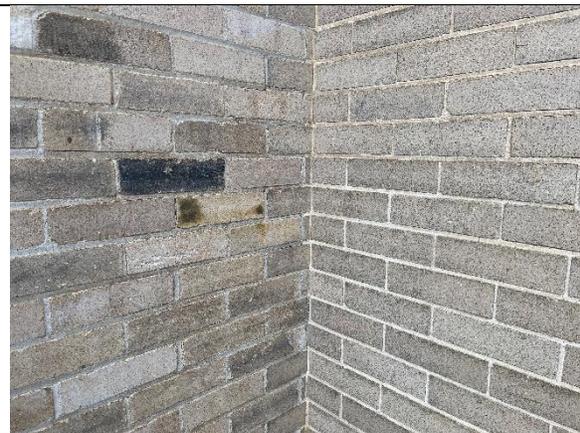
Photo 47: Variation in the brick at the north entrance, with more uniform and less

<p>damaged bricks (right side) compared to the return wall (left side)</p>

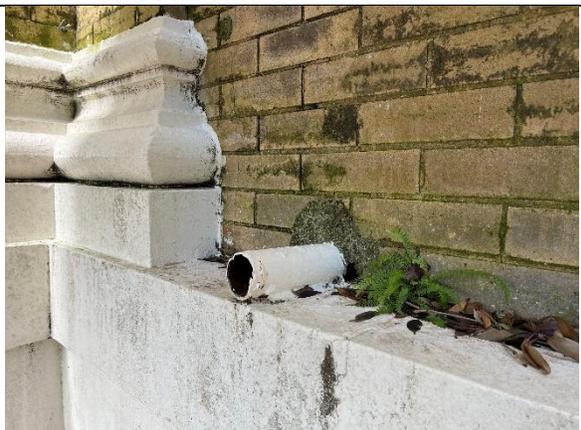
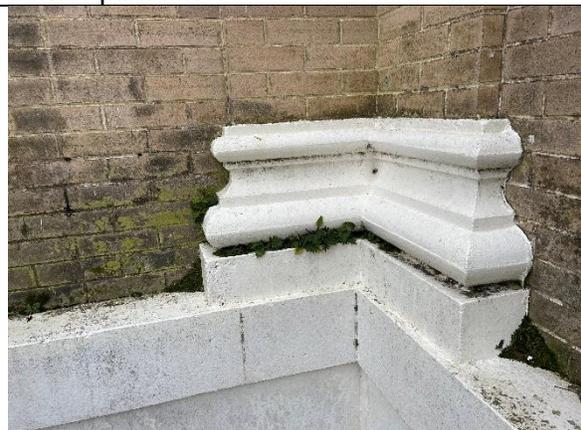
<p>Photo 50: Organic growth at the base of brick in a shaded area with an unknown drainage pipe.</p>	<p>Photo 51: Organic growth at the base of brick in a shaded area.</p>

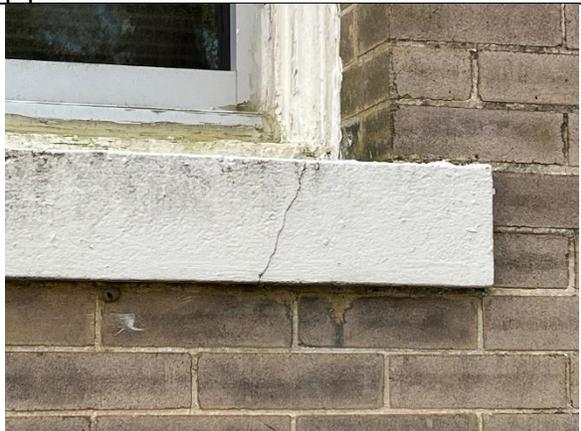
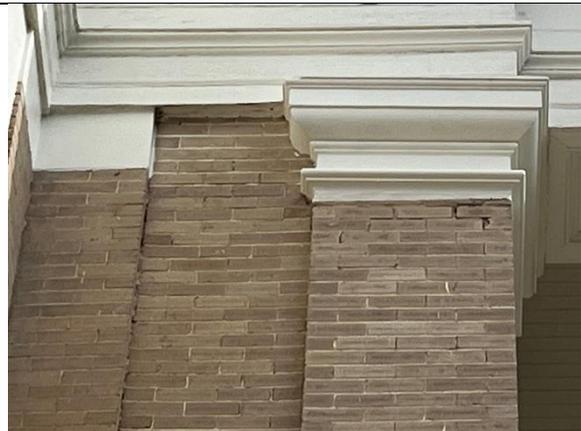
<p>Photo 52: Cracking in a masonry sill.</p>	<p>Photo 53: Damaged / cracked brick near the top of a pilaster.</p>

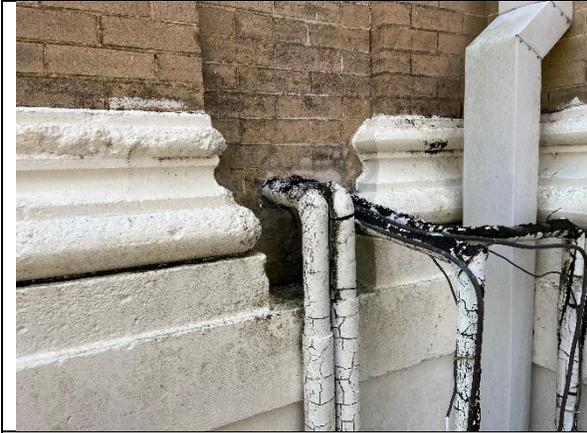
Photo 54: Multiple conduit penetrations through section of brick. Note improper seal detailing.

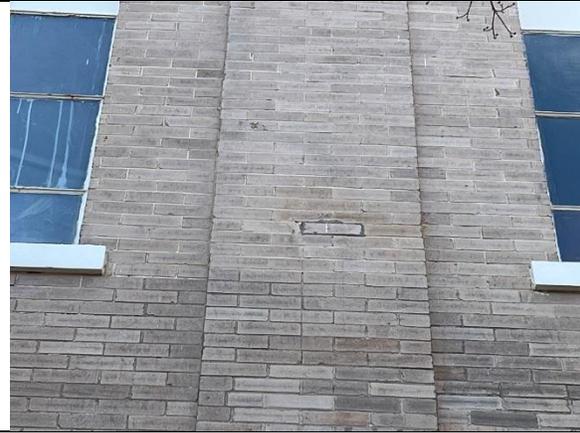
Photo 55: Previously repaired brick unit within a pilaster.

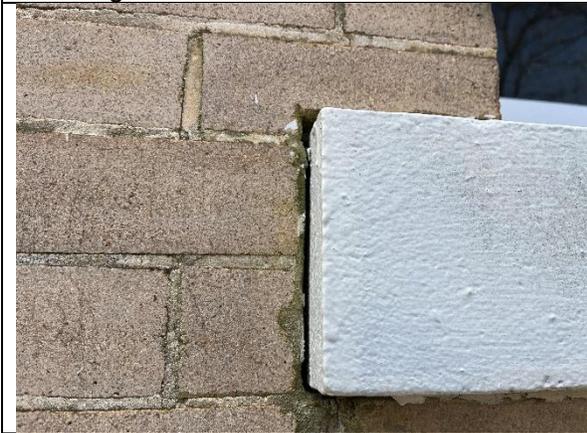
Photo 56: Open / unsealed joint between brick and sill masonry.

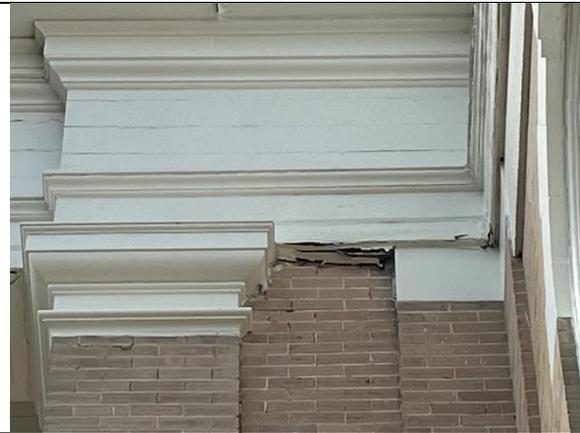
Photo 57: Damaged wood trim at the south entrance, just above the top of brick.

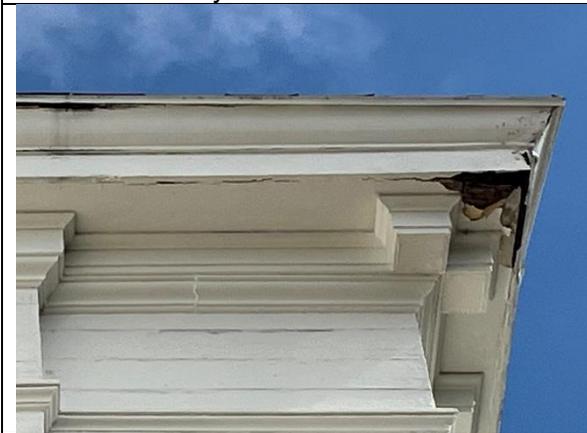
Photo 58: Damage to the wood soffits at the south entrance.

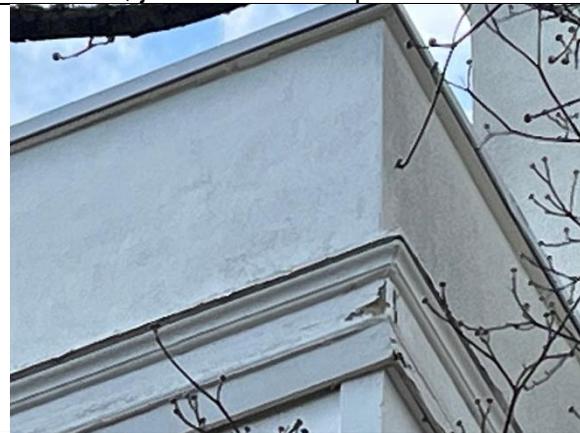
Photo 59: Damage to the corner of wood trim at the east elevation.

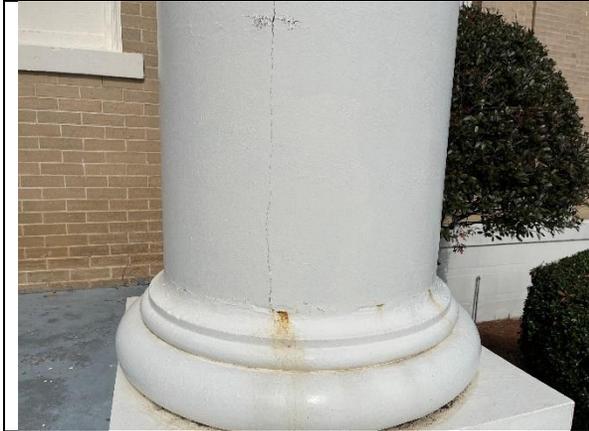
Photo 60: Water weeping from the base of one of the south columns.

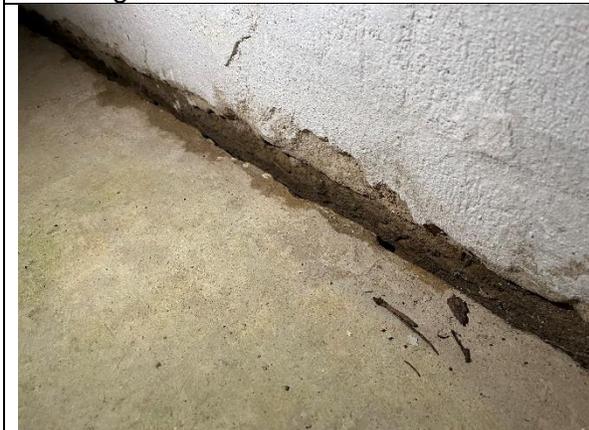
Photo 68: Basement floor to wall condition showing open joint with water dampness.

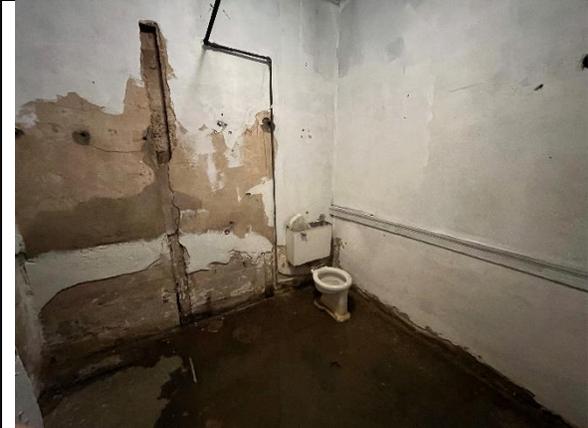
Photo 72: Standing water within an basement bathroom. Note moisture-damaged wall surfaces

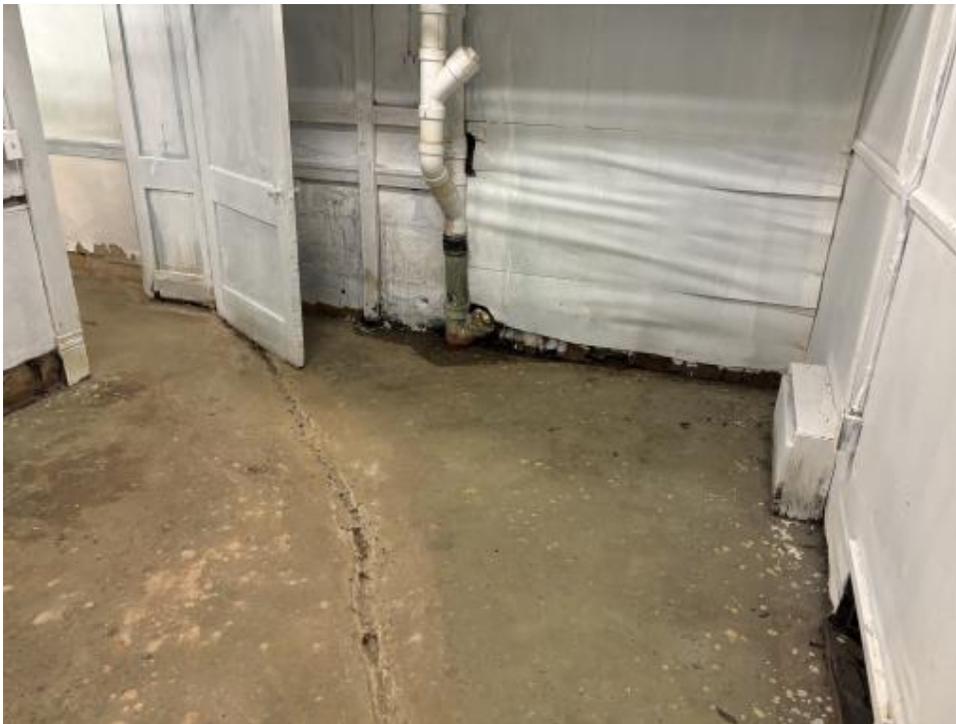
Photo 2- General view of water damaged to building components in basement area.

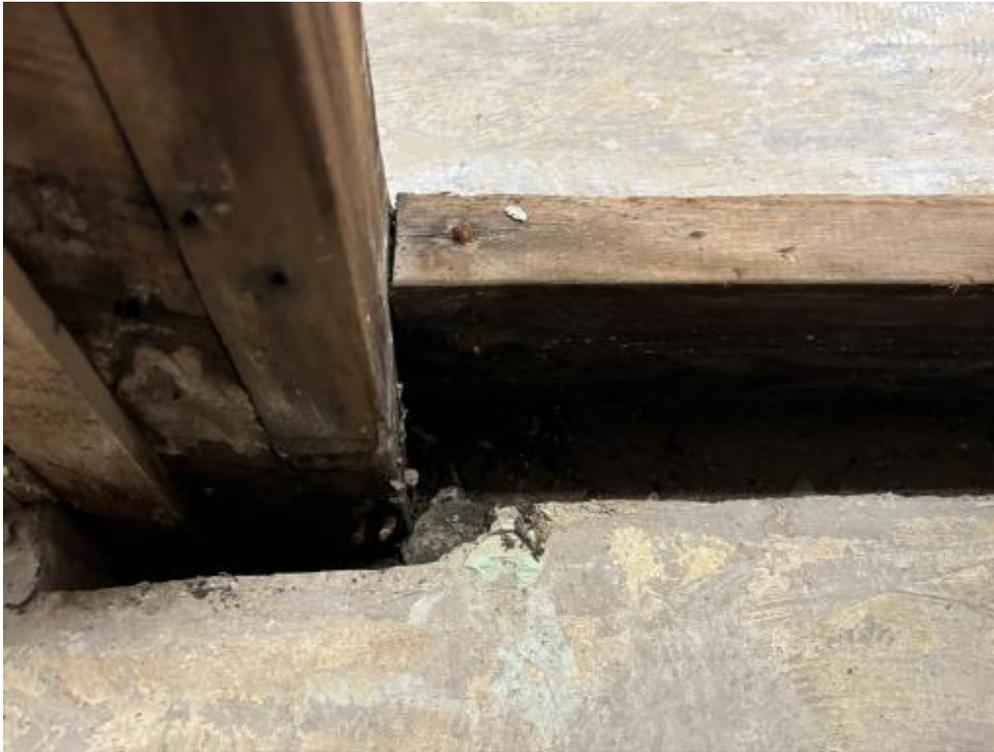
Photo 3- General view of visible water damage and apparent mold growth in basement area

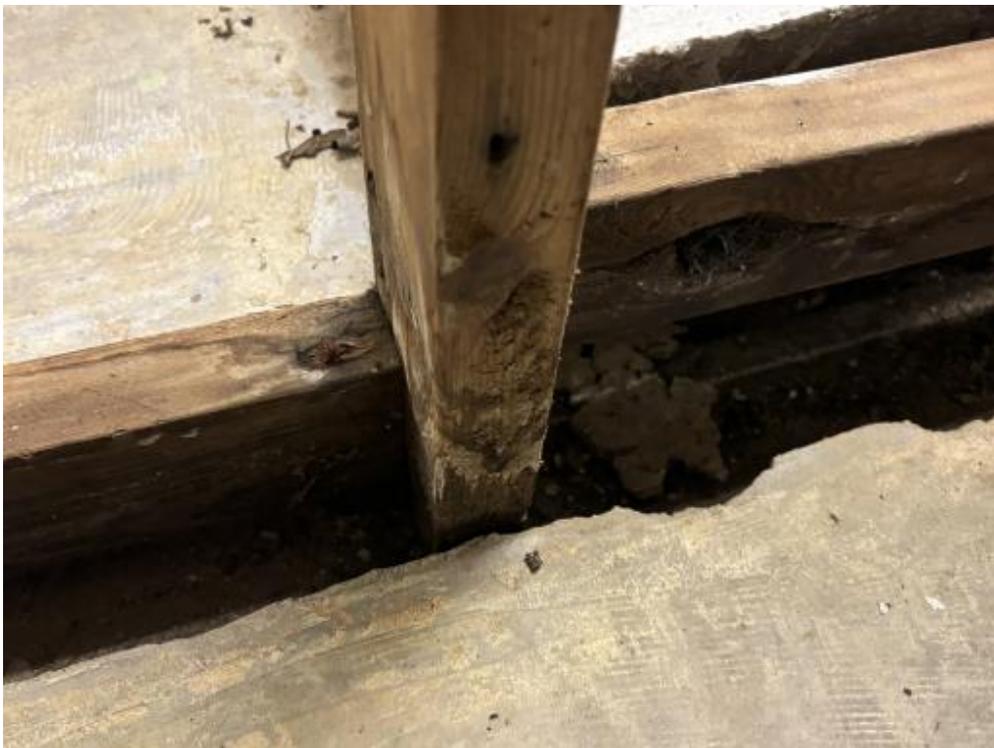
Photo 3- General view of visible water damage and apparent mold growth in basement area

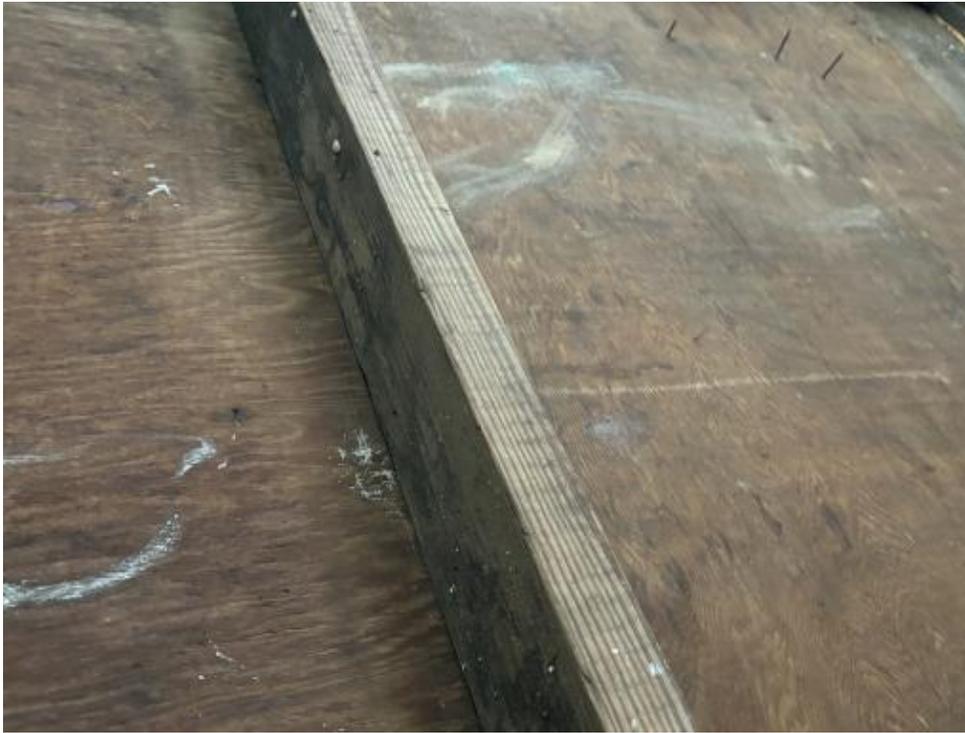
Photo 5- General view of visible water damage and apparent mold growth in basement area

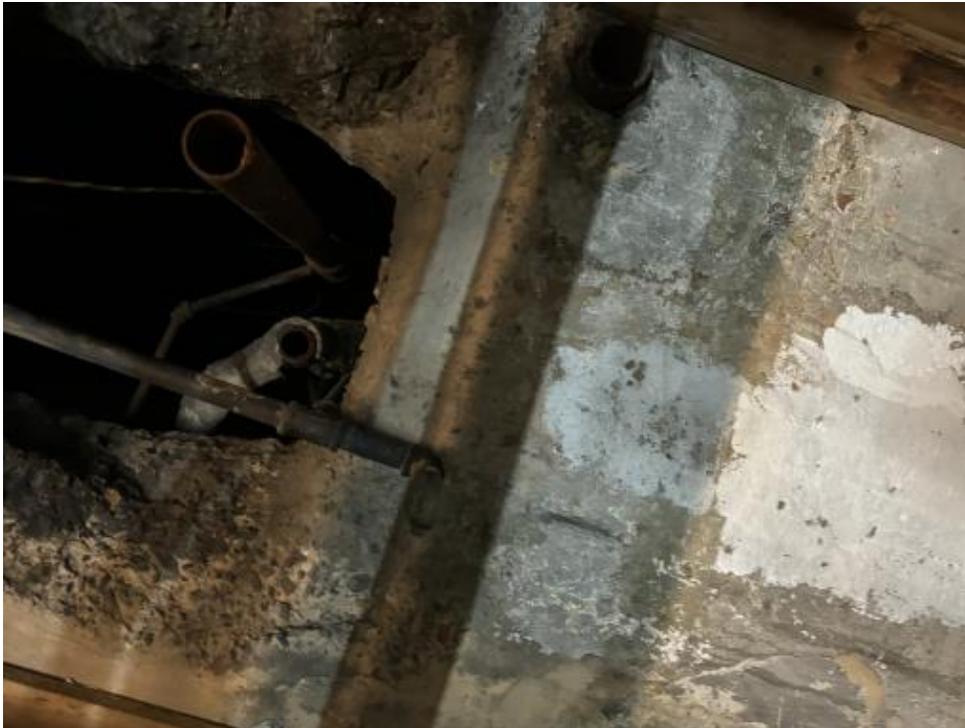
Photo 6- General view of hole in basement slab and broken pipes
