# Existing Facilities Assessment

## Dodge County Courthouse

Date: May 16, 2025

## Dodge County Courthouse Existing Facilities Assessment

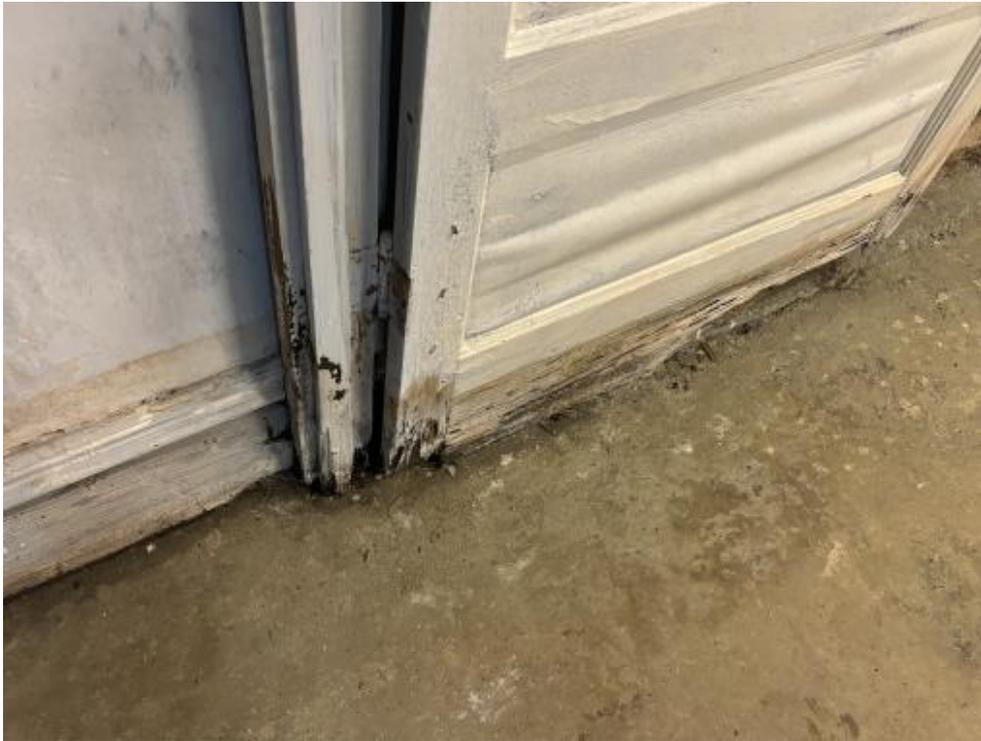
Photo 7- General view of water damaged building components in basement area

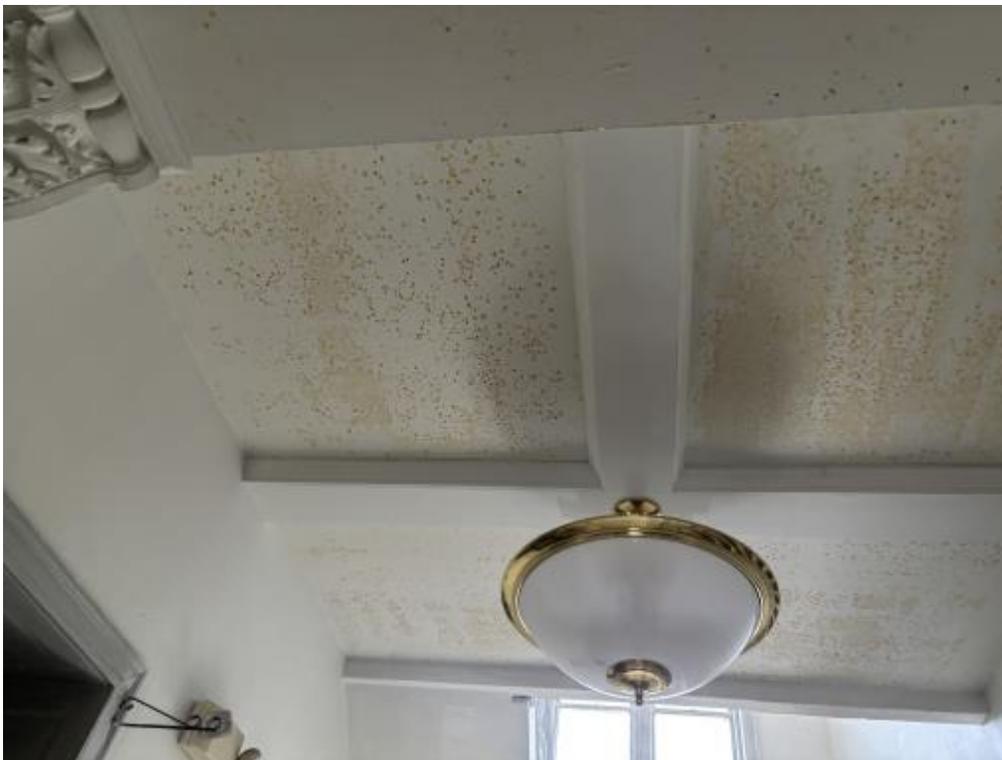
Photo 8- General view of "water staining on plaster ceiling at stairwell of 1<sup>st</sup> floor

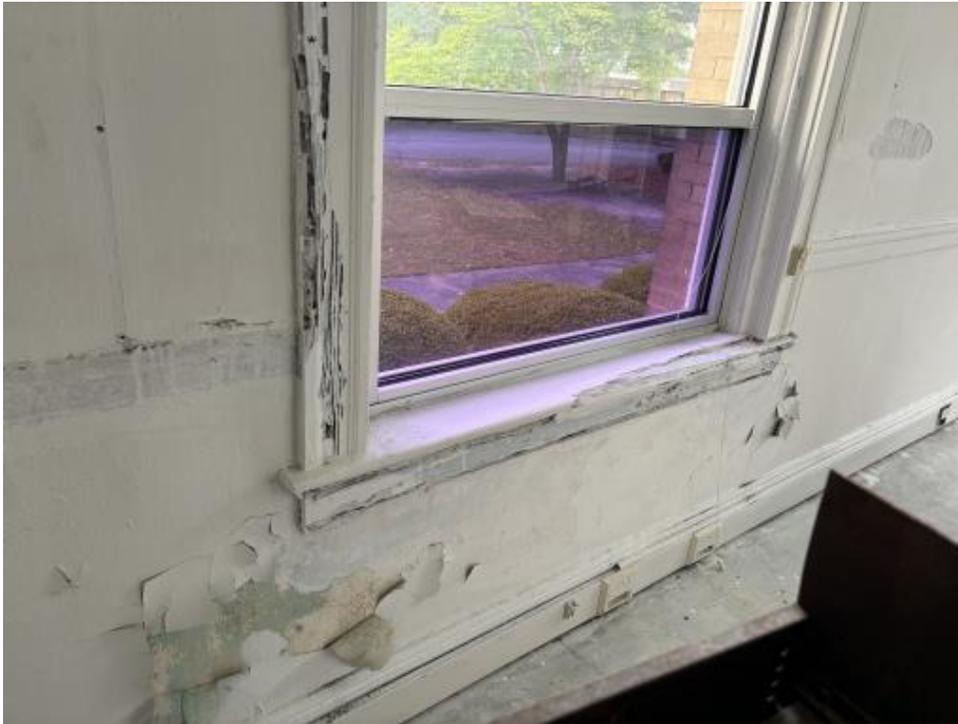
Photo 9- General view of moisture damage plaster wall and window components 1<sup>st</sup> floor

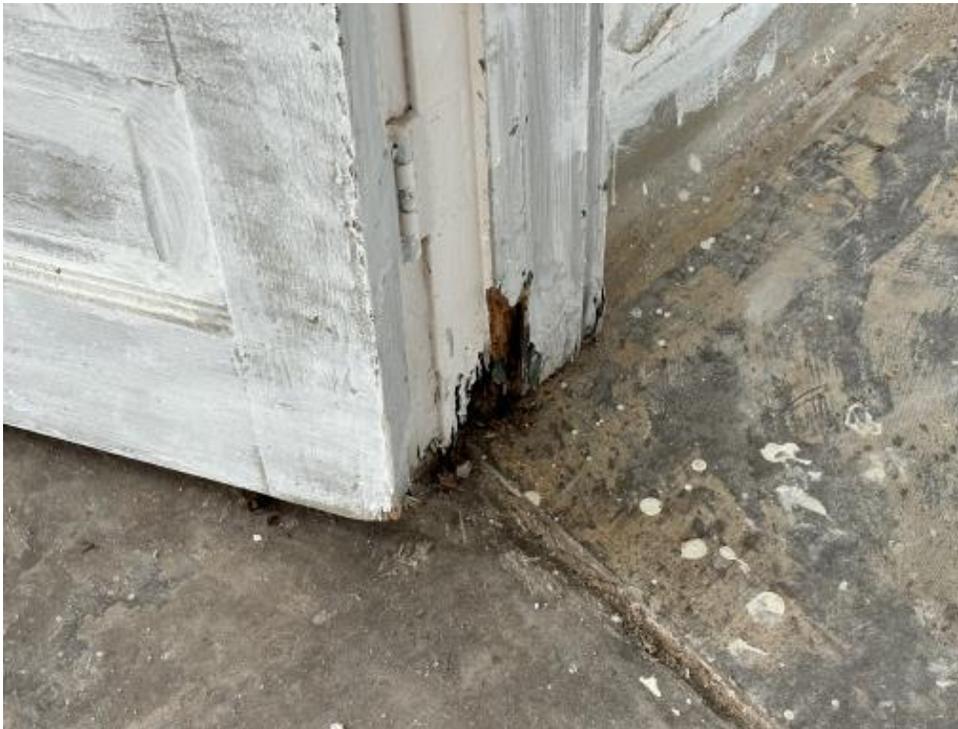
Photo 10- General view of moisture damaged building components 1<sup>st</sup> floor

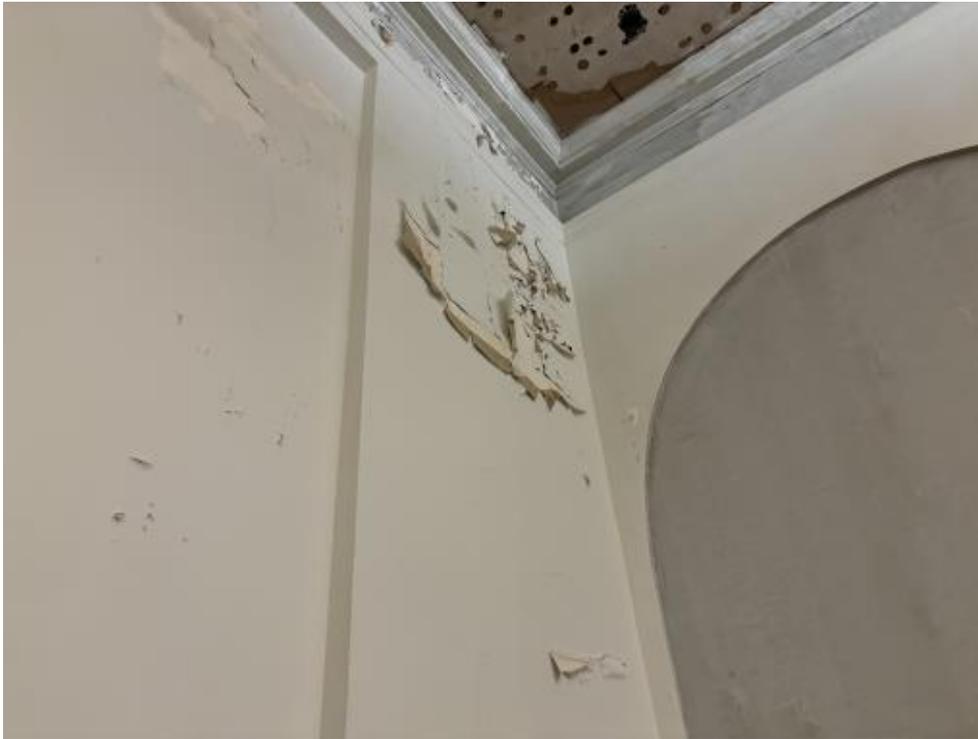
Photo 11- General view of moisture damaged plaster wall coat 1<sup>st</sup> floor

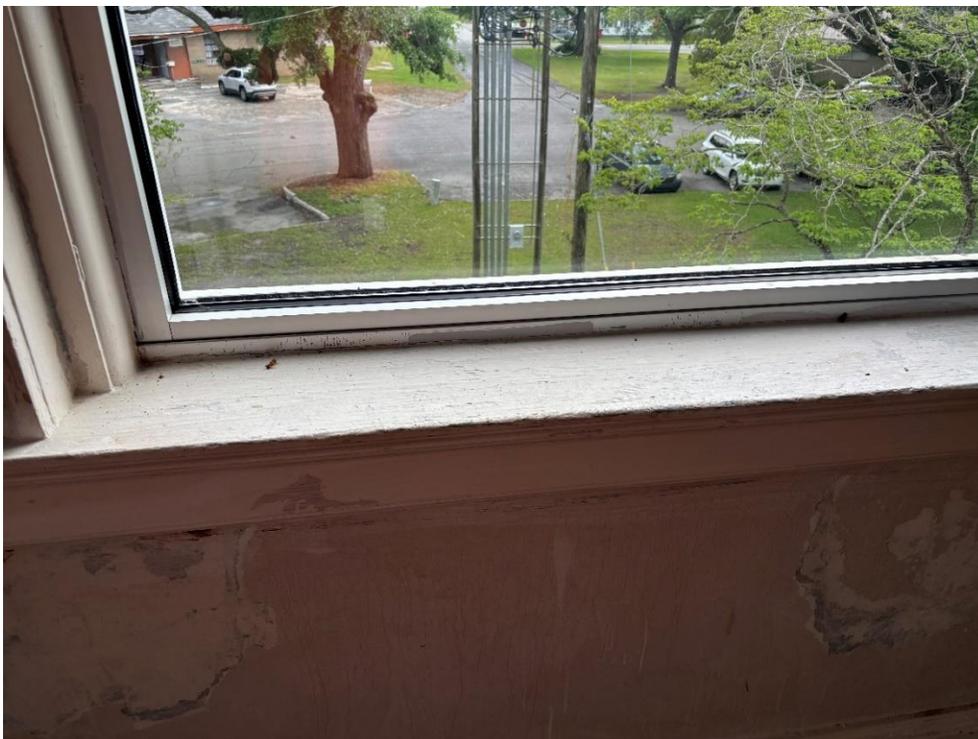
Photo 12- General view of moisture damaged plaster wall coat and window components 2<sup>nd</sup> floor
