# Existing Facilities Assessment

## Dodge County Courthouse

Date: May 16, 2025

## Dodge County Courthouse Existing Facilities Assessment

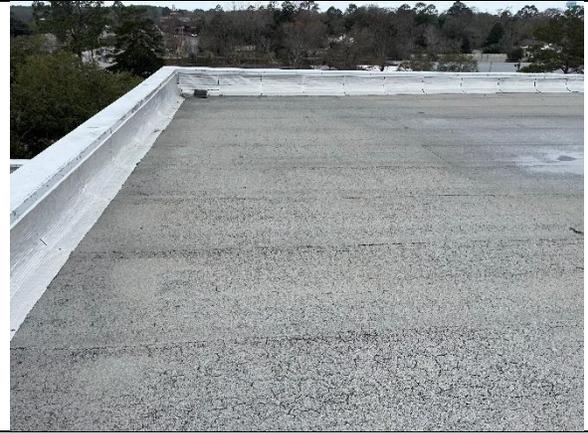
Photo 6: Overview of the main low-sloped roof, showing parapet wall and wall flashing system

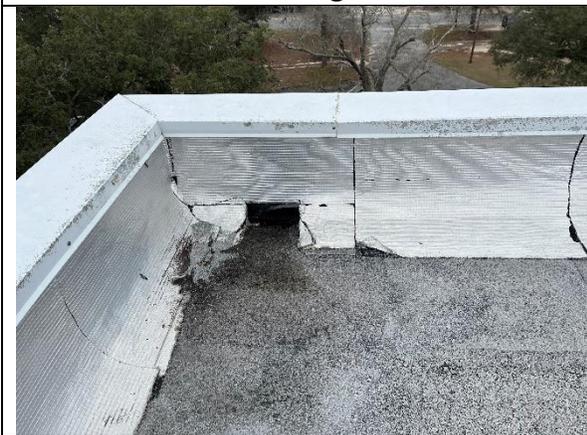
Photo 7: Main roof area, showing parapet wall, wall flashing system, metal coping, and primary thru-wall scupper detailing.

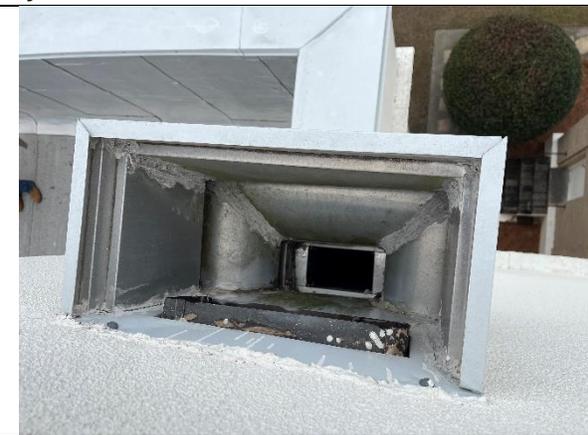
Photo 8: Scupper collector head and downspout for the main roof.

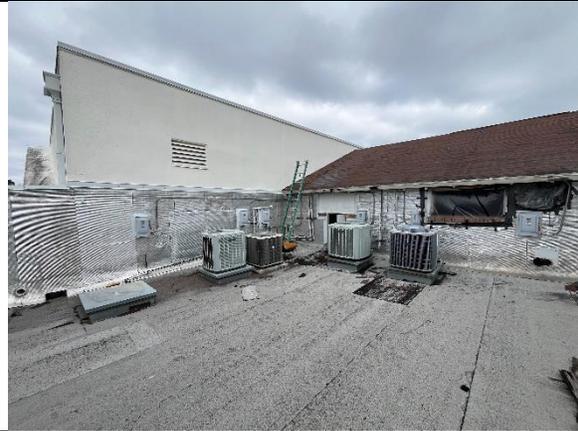
Photo 12: Overview of the south-west level 2 roof area, showing high parapet wall, wall flashing system, water stains, and rooftop units

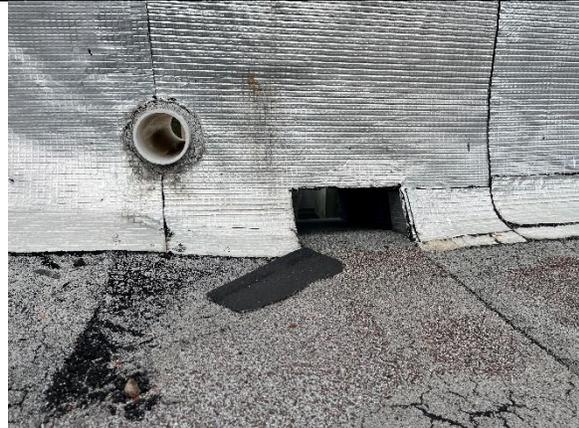
Photo 13: South-west level 2 roof area showing scupper and improperly flashed and located overflow scupper pipe.

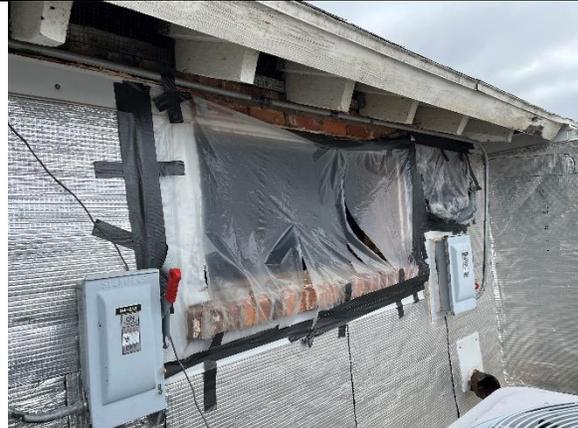
Photo 14: Rising wall detailing and temporary seal to the a wall opening.

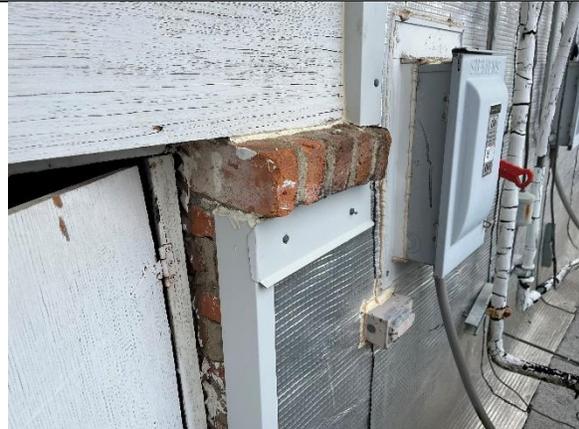
Photo 15: Rising wall showing various materials and conditions at the attic exterior, potential for water entry.

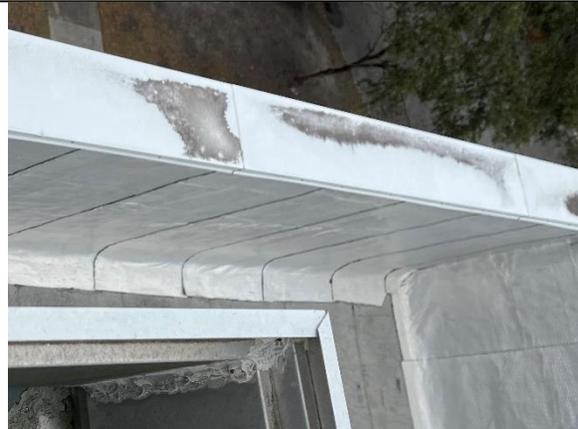
Photo 16: Metal coping with staining / ponding.

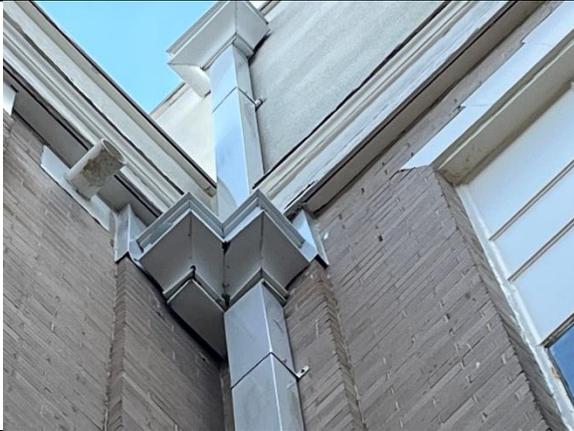
Photo 19: Downspout tie-in and overflow pipe from the main and a level roof area.

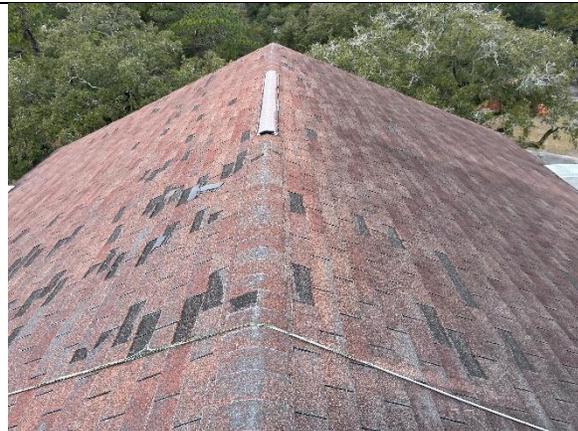
Photo 21: Overview of the north shingled roof, showing aged / missing / damaged shingles

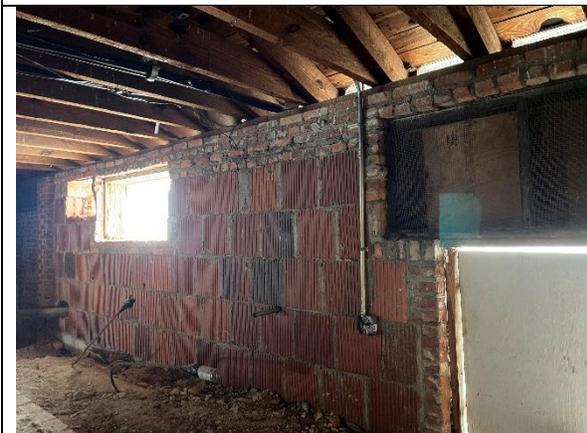
Photo 26: Attic terra-cotta wall with open soffit for ventilation

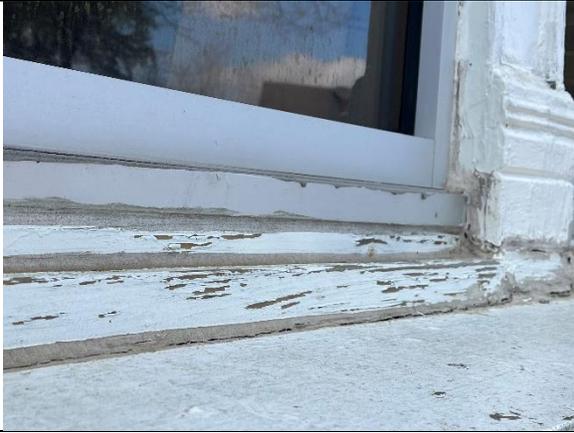
Photo 32: Detailed view of a typical retrofit aluminum assembly with existing wood trim. Note signs of moisture and sealant repairs.

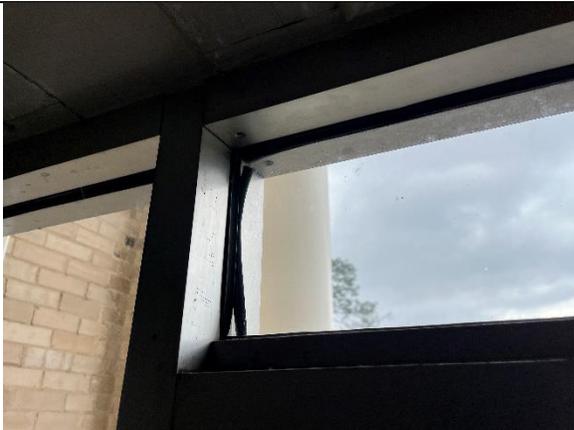
Photo 34: Aluminum-framed transom above a doorway with loose / displaced gaskets.

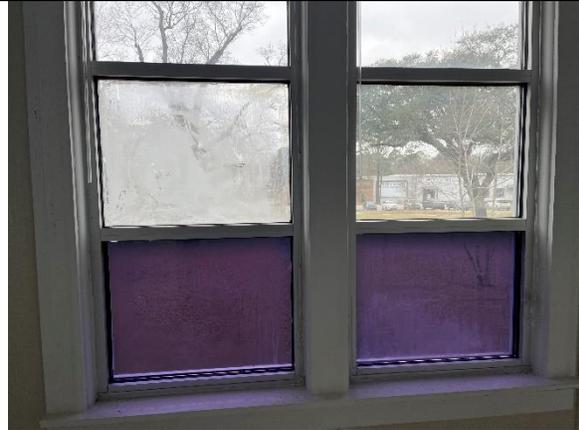
- Aluminum-framed assemblies were in generally better condition than their wood counterparts; however, multiple units were observed to have condensation between the panes, suggesting failure of the seal. Gaskets were showing signs of deterioration. Additionally, the wood trim / surrounds were subject to the same issues described above.

Photo 35: Aluminum-framed unit with condensation between the glass units.

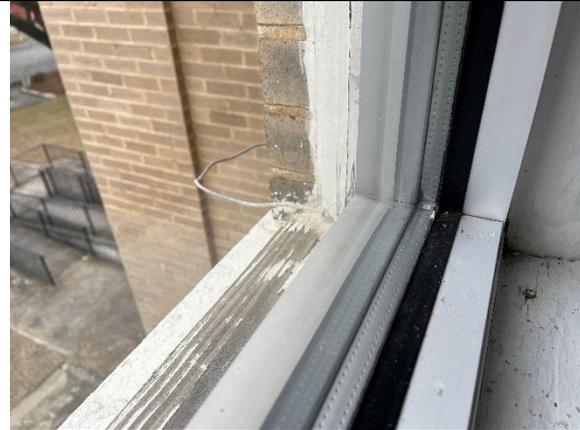
Photo 36: Window units with a film applied to the glass.

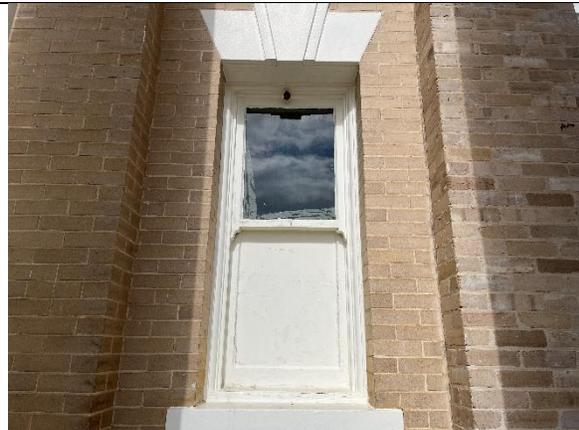
Photo 37: View of a retrofit aluminum window within a wood opening. Note signs of moisture and sealant repairs.

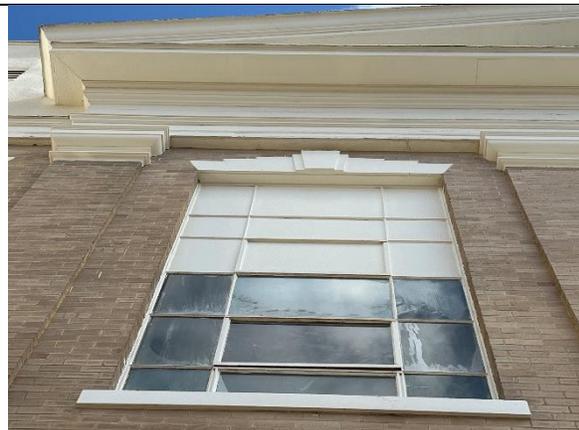
Photo 39: Decorative glass block and arched wood-framed window assembly with film applied to the glass portions, main entrance.

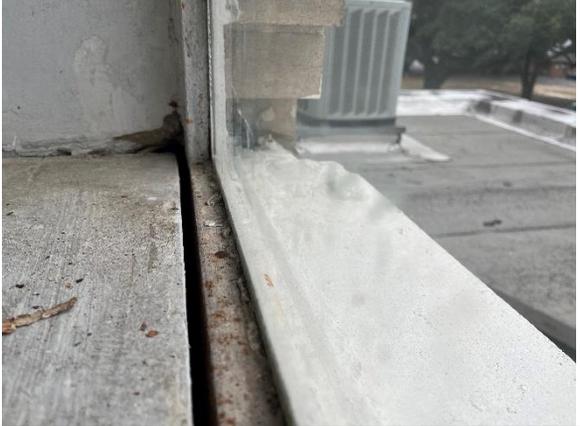
- Steel-framed assemblies appeared to be in poor condition, with broken glass, corrosion, and failing glazing compound. These windows were single-pane, as with the wood-framed assemblies. Some assemblies had panes replaced with air conditioning units, as well as possible films.

<p>Photo 40: Typical steel-framed window at the second level.</p>	<p>Photo 41: View of a steel-framed window with an air conditioning unit mounted in the bottom center panel and multiple broken glass units.</p>

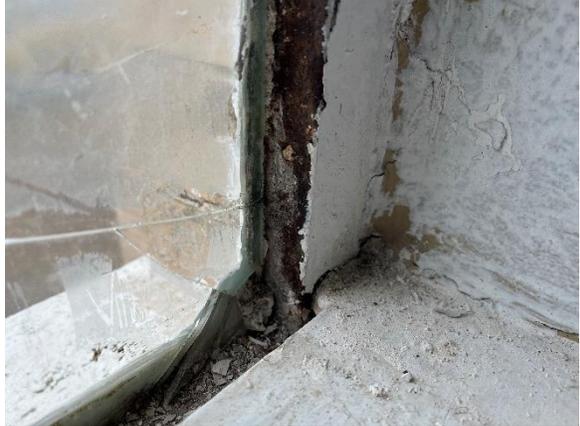
<p>Photo 42: View of deteriorated framing and glazing compound, as well as broken glass.</p>	<p>Photo 43: Detailed view of the window sill of a steel-framed assembly.</p>

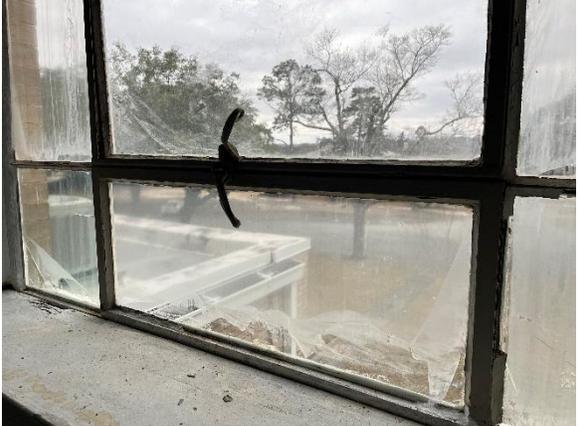
<p>Photo 44: Detailed view of the window sill to jamb of a steel-framed assembly. Note signs of moisture damage and sealant open / repairs.</p>	<p>Photo 45: Typical operable lower unit at a steel-framed assembly.</p>

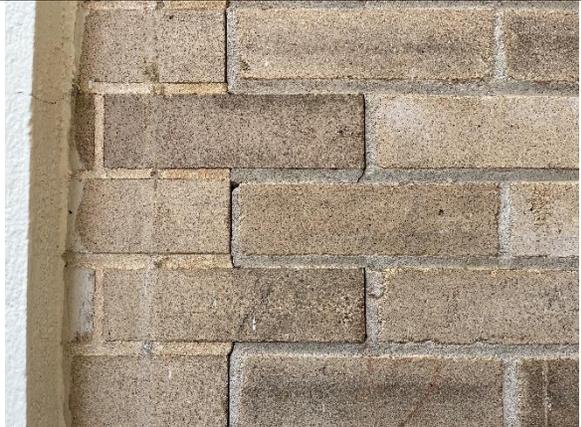
<p>Photo 48: Cracking at a joint between disimilar mortar and brick units.</p>	<p>Photo 49: Separation between brick at a corner pilaster.</p>

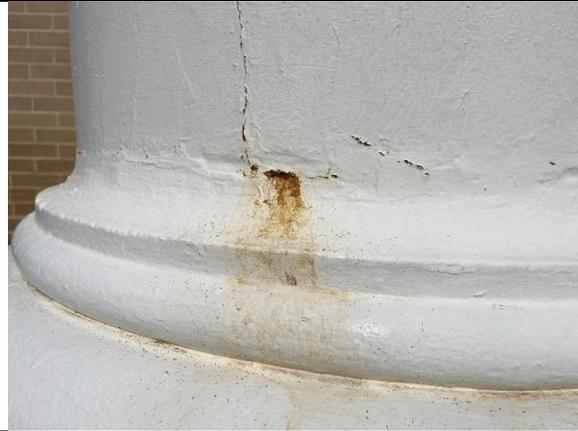
Photo 61: Enhanced view of water weeping from the base of one of the south columns.

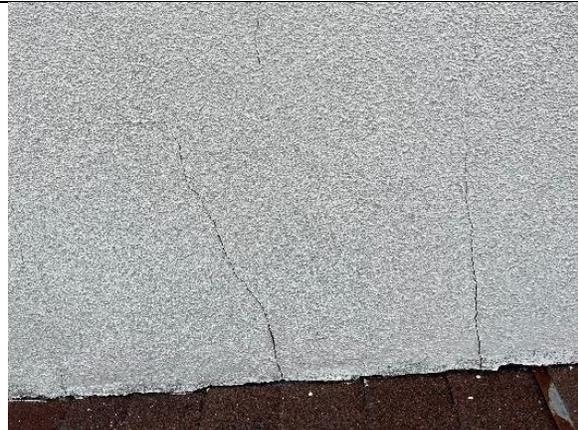
Photo 63: Cracking within a plaster clad walls above the shingle roof.

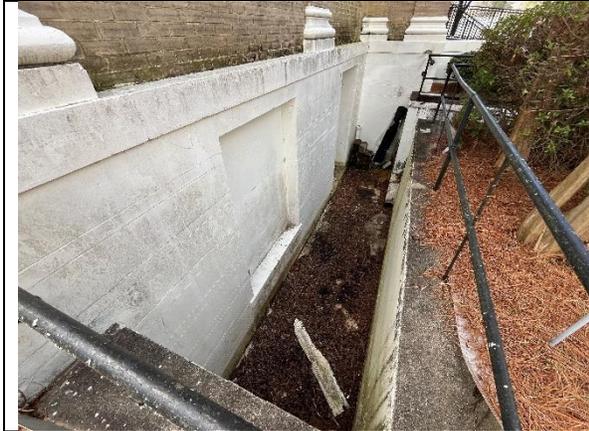
Basement: The basement is located at the north side of the building, with two entrances on the north and one on the east. Grade is held-off the basement by a few feet by mean of retaining walls. Basement walls contain openings; however, these openings have been infilled. Basement contains significant signs of water leakage throughout flooring and perimeter walls. Drainage within the basins surrounding the basement contained staining water. Basement crawl-space appeared to extend through the rest of the building; crawlspace did not appear to contain vapor limiters, and venting capabilities are unknown.

Photo 64: Overview of the basement exterior at the north elvation.

- Remediate the drainage for the basins adjacent to the basement wall so that water does not pond within them or against the exterior wall.
- Apply a surface waterproofing coating to the exterior basement walls and transition to the base of the basins.
- If window openings are to be abandoned, provide permanent concrete / masonry infill to each opening.
- It was unclear the source of standing water within some of the basement rooms. Further study is recommended to determine if plumbing and / or groundwater is contributing to this. If groundwater is a contributor, active water removal systems such as sump pump systems may be required.
- Consider adding floor or storm drains adjacent to the basement walls or in front of doorways

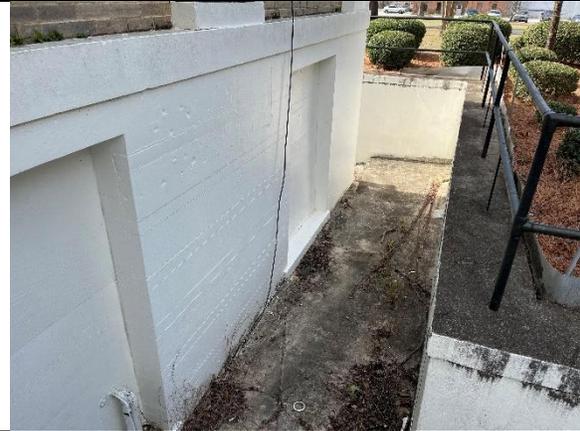
Photo 65: Overview of the basement exterior at the north elvation.

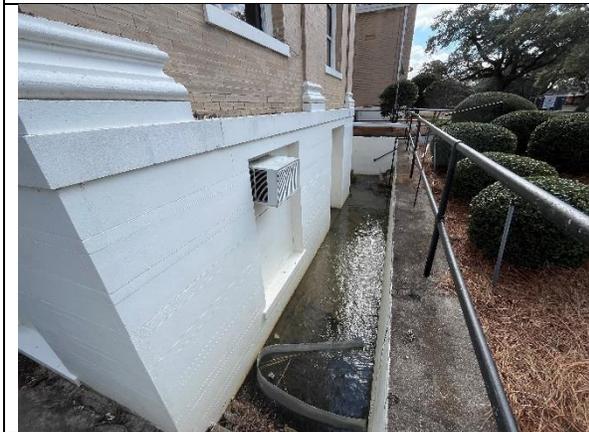
Photo 66: Overview of the basement exterior at the west elvation. Note the basin steps down along the west side and contains standing water.

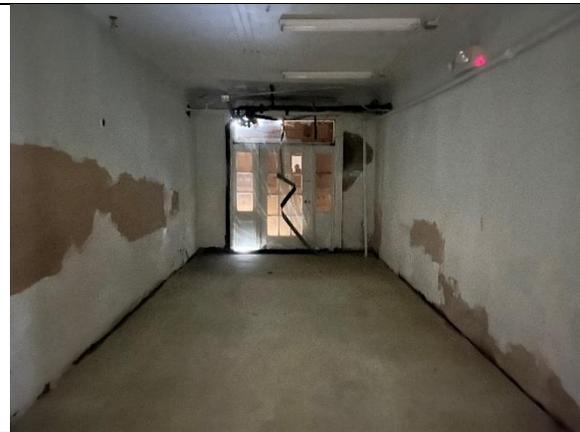
Photo 67: Basement room overview.

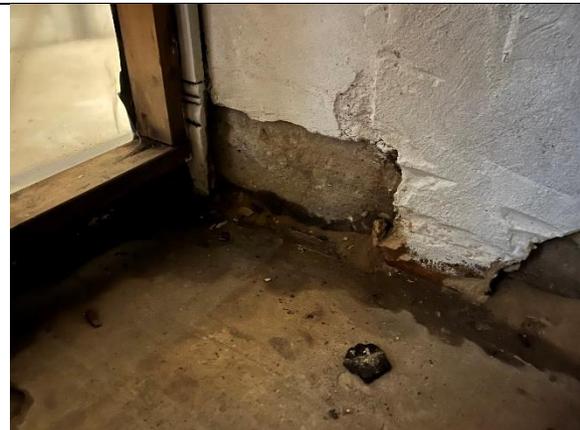
Photo 69: Water dampness and wall damage along a basement wall.

- Interior basement walls require investigation for dampproofing, followed by patching and repair in order to eliminate existing issue.
- Enhancements to landscaping drainage, such as adequate perimeter drainage lines, French drainage, or other means and methods to reduce the amount of water which may access the basement walls (This could be completed along with the downspout pipe system installation).
- Regarding the crawlspace, further study may be required to determine the extent of remediation needed, including active / passive venting and installation of a vapor barrier.

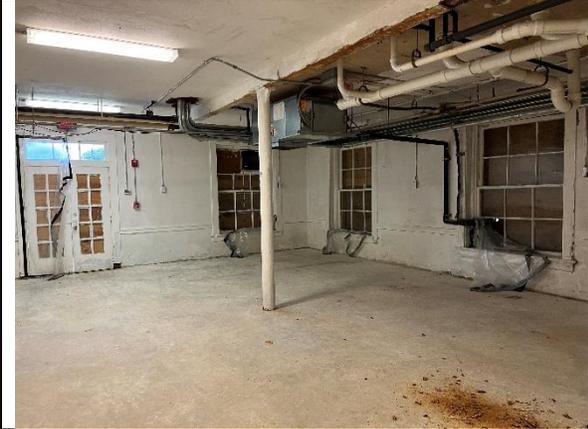
Photo 70: Basement overview.

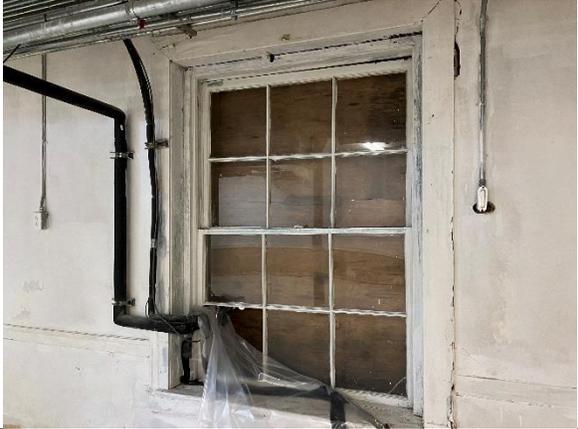
Photo 71: Existing blocked-off window within a basement room.

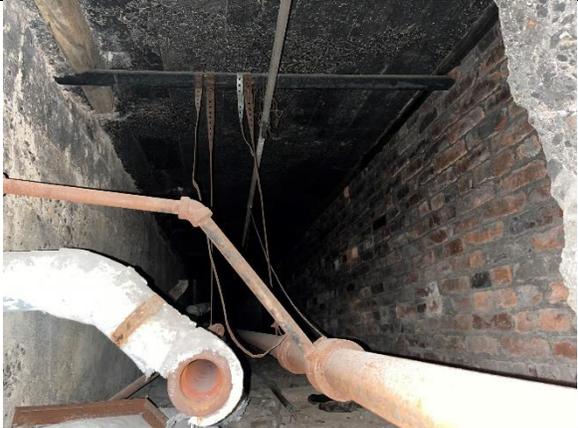
Photo 73: Basement crawl-space.

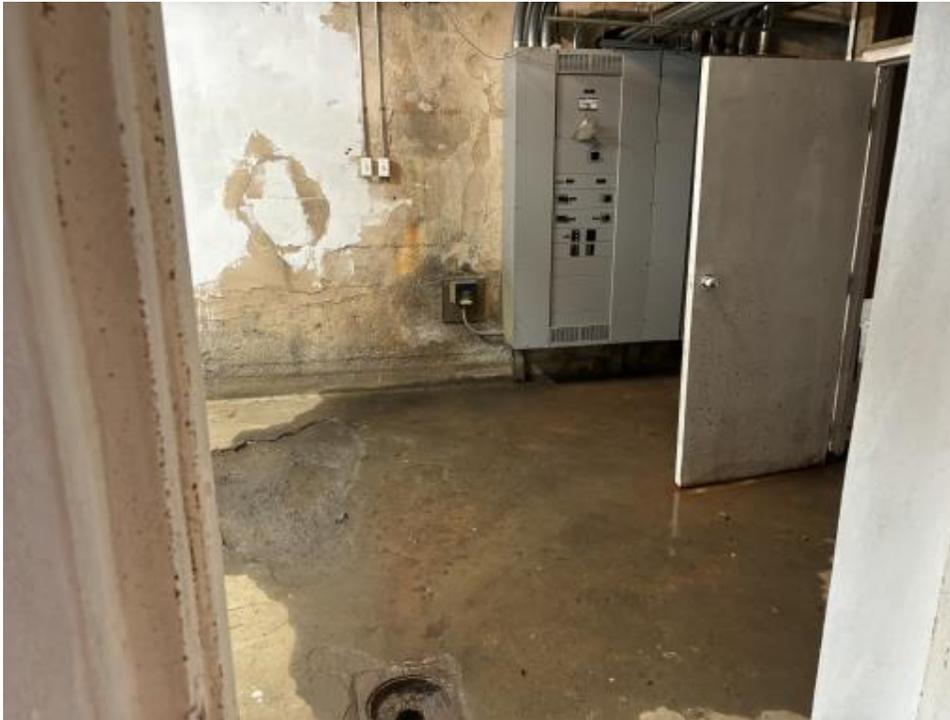
Photo 1- View of water intrusion in basement area

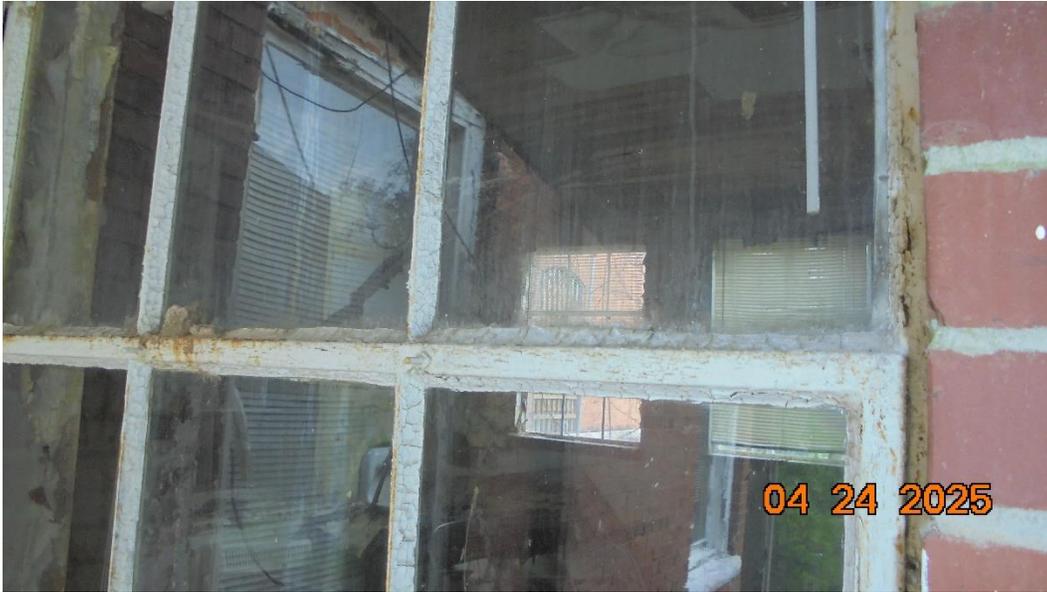
General Photo of the exterior of the exterior window glaze
